# Damage assessment of Nepal heritage through ambient vibration analysis and visual inspection

The experimental investigation was carried out on two Nepali temples damaged by the 2015 Gorkha earthquake known as Radha Krishna temple (Teku) and Pancha Deval complex (Pashupati area). These temples are part of the heritage protected by UNESCO.

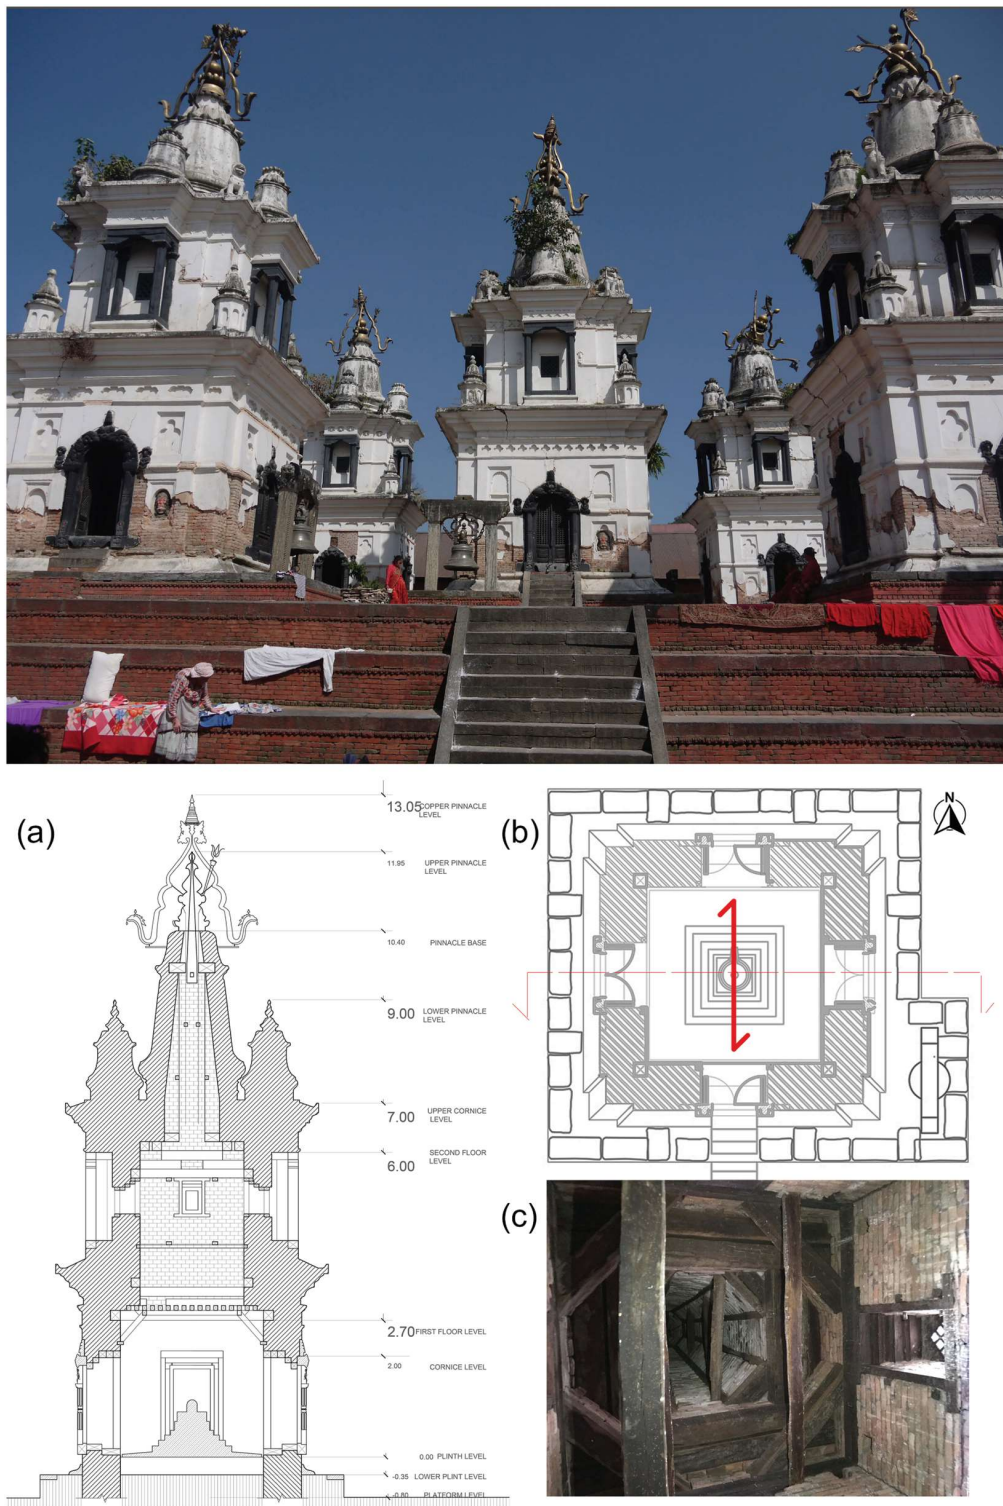
**FIGURE 1** Pancha Deval complex, (a) section, (b) ground floor, and (c) roof detail

The Pancha Deval complex (Figure 1) is located in the Pashupati area, along the Bagmati River. It is currently used as a refuge for elderly people in financial difficulties. The complex was built in the 19th century, and it is composed of five buildings placed on an impressive base (Figure 1). The base has a square plan, 28 m per side, consisting of four decreasing upwards.

The five buildings have the same structural typology, identical architectural composition, and dimension. The only exception concerns the dimension of the central building, this building is 15 m long and 15 m tall. The other buildings are 13 m high, and they have a square plan, and they are composed by two floors (Figure 1a), only the first one is accessible (Figure 1b). The structure is masonry (brick-mud masonry), wooden floor, and the impressive roof is made of reinforced timber masonry (Figure 1c).

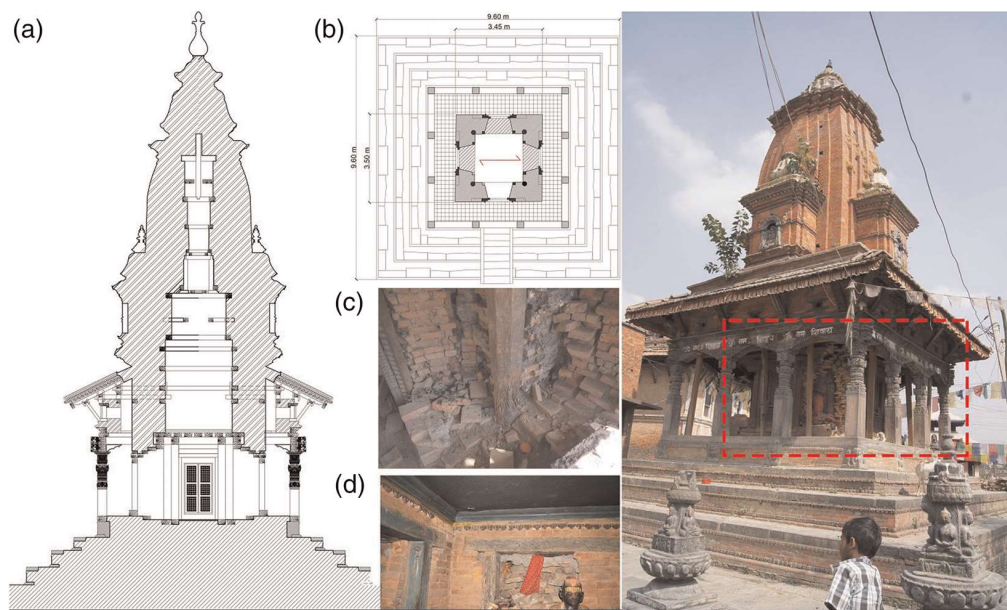
**FIGURE 2** Radha Krishna Temple, (a) cross section, (b) ground floor, (c) North–West corner, (d) inside view

The Radha Krishna temple has an externally undamaged roof; the masonry on the ground floor has completely lost its static capacity due to the complete expulsion of the corners. The building has not collapsed thanks to the timber colonnade. The colonnade has responded positively to the horizontal stress of the earthquake despite eight columns appear cracked and four columns need replacement (Figure 3a,b). The timber windows support the non-load-bearing

wall. The windows are high as the ground floor, and they have played a fundamental role in the dissipation of energy induced by the earthquake. Currently, they present an out-of-plane mechanism but are still able to support the completely cracked masonry behind them (Figure 3c). The masonry of the ground floor is completely collapsed in the four corners (Figure 3d), and it is possible, observing the timber reinforcement. This reinforcement appears damaged or

without support. We can assume that the masonry has completely lost its function and the structure is supported by the timber elements (colonnade, architraves, and masonry interior columns).

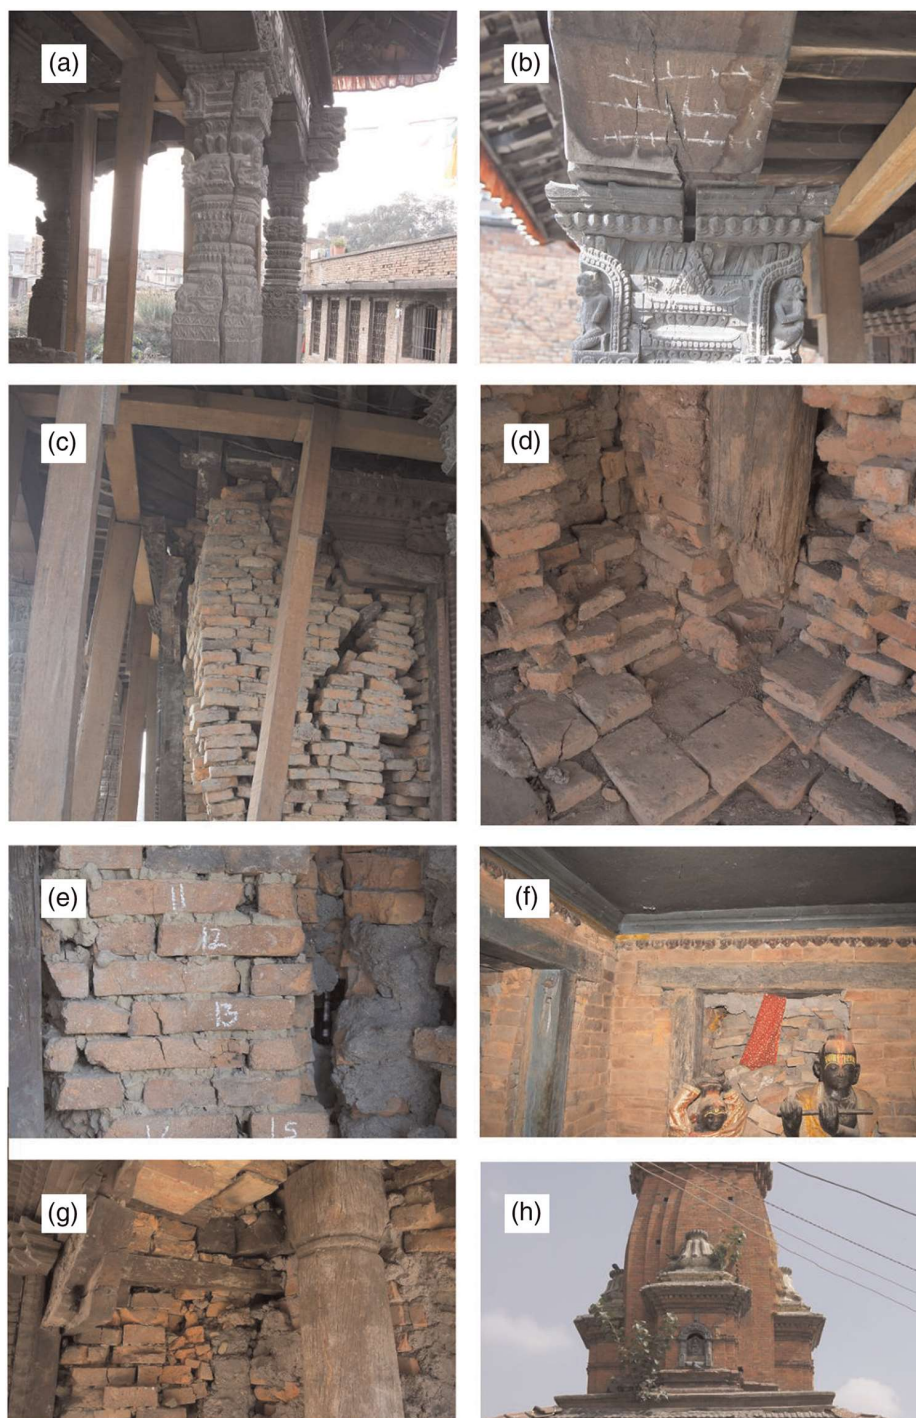
**FIGURE 3** Global damage survey of Radha Krishna Temple

The visible mud mortar joints are thick 1.5–2 cm, and the bricks have different dimensions, and they are not positioned in a regular way (Figure 3e). Punctual consolidation interventions without an overall and unitary strategy are present.

Observing the masonry of the ground floor, from the inside, it is possible to see on each side timber architrave systems inserted in the walls in correspondence with the external timber windows (Figure 3f). Also these timber reinforcements helped to dissipate the horizontal dynamic action. The architraves that make up these systems are inflected, and the wall beneath them is cracked.

Horizontal reinforcing timber elements were observed between the architraved systems and the external timber openings (Figure 3g).

The presence of vegetation is also an indication of the maintenance absence (Figure 3h).

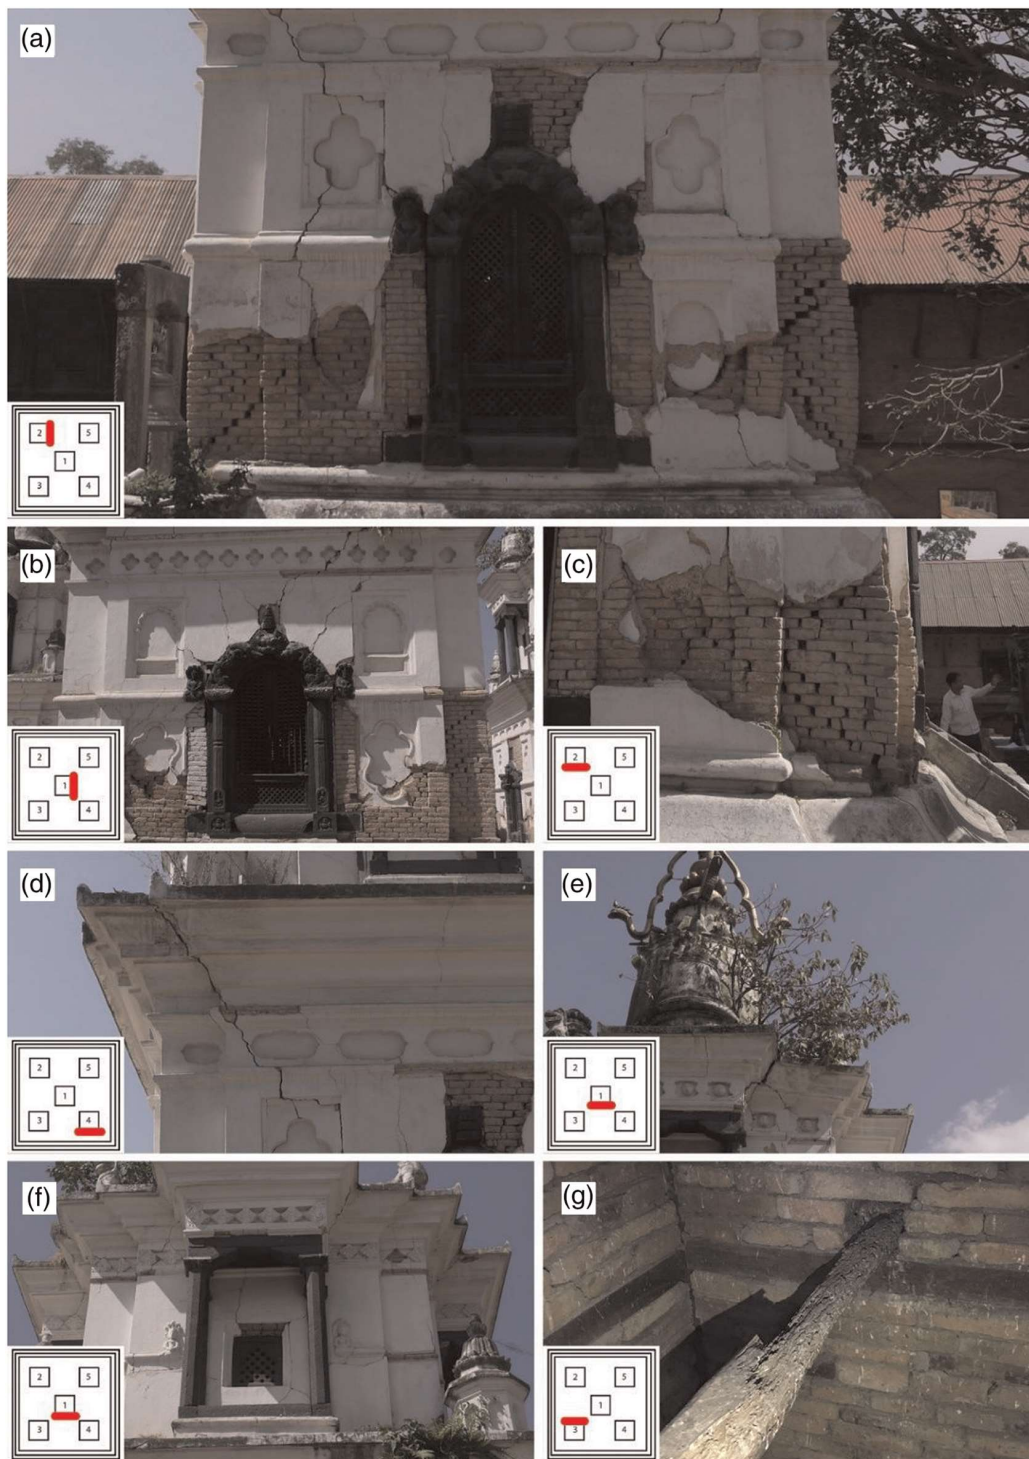
**FIGURE 4** Global damage survey of Pancha Deval Complex

The Pancha Deval complex presents in all buildings the different levels of damage. We observed a variation of the wall section between the ground floor and the upper floor. Specifically, the masonry on the upper floor has a larger section than the ground floor. The load generated by the masonry on the first floor is supported by the wooden floor reinforced by struts (inclined wooden elements) placed under it, which are discharge into the masonry on the ground floor.

Several cracks were observed at the base of the struts, in all temples. Many elements that make up the reinforcement of the roofs are deteriorated or absent. Other recurrent damage mechanisms observed in different buildings are cracks extended to the entire ground floor (Figure 4a). Radial cracks observable around the stone portal inserted in the wall that describe how the two materials of different stiffness have responded to the action of the earthquake. The stiffer stone has triggered breaking mechanisms in the masonry (Figure 4b). Diagonal cracks are visible near the wall corners with sliding along the horizontal direction of the bricks with possible ejection of the corners (Figure 4c). Important cracks in the cornices caused by the variation in geometry (Figure 4d) are present. Cracks are present (where vegetation is present) that allows water to enter, weakening already compromised structures (Figures 4e). Cracks “X” shape around the openings of the upper floors (Figure 4f) are visible. Wooden element deterioration inside the structure due to absence maintenance (Figure 4g) is visible.

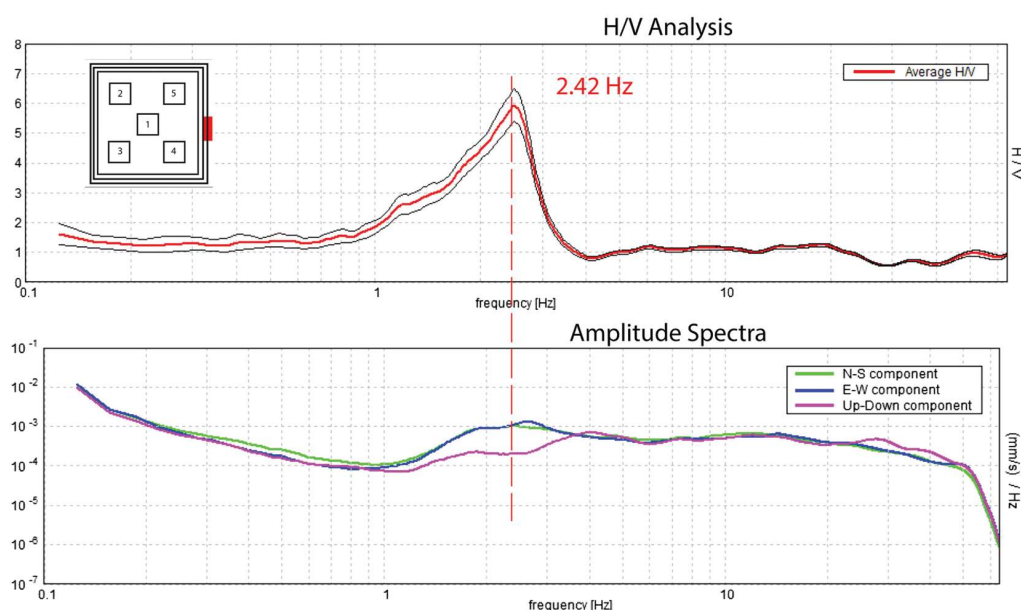
**FIGURE 5** H/V analysis (base ground floor, East front) and relative spectra

In the Pancha Deval complex, the traces related to the base were analysed with a 10% smoothing. The curves have only one clearly visible peak. The result of a single measurement is presented below. This measurement was recorded on the ground floor of the base, on the East side (Figure 5).

The recorded peak is 2.42 Hz and the “amplitude spectra” graph presents a curvature of the up-down curve as “ogive,” typical shape of the resonances of the ground. This curvature is in correspondence of the H/V maximum. Under normal conditions the spectral components NS, EW, and Z (vertical) have similar amplitudes. At the resonance frequency of the ground, the H/V analysis presents a maximum linked to a local minimum of the vertical spectral component, which determines an ogive shape like those indicated in the spectra below (Figure 5, dotted line).

This ogive shape is indicative of stratigraphic resonances<sup>38</sup>. Another indication, linked to the presence of ground resonance, is the shape of H/V maximum. This pick is large and close at twice of the peak frequency, and this is a typical condition of ground resonance. This situation also occurred in all other measurements carried out on the base of the Pancha Deval. Table 1 compares the individual peak frequencies of each measurement with the mean peaks obtained in the H/V analysis; in red are under light, the low frequencies.

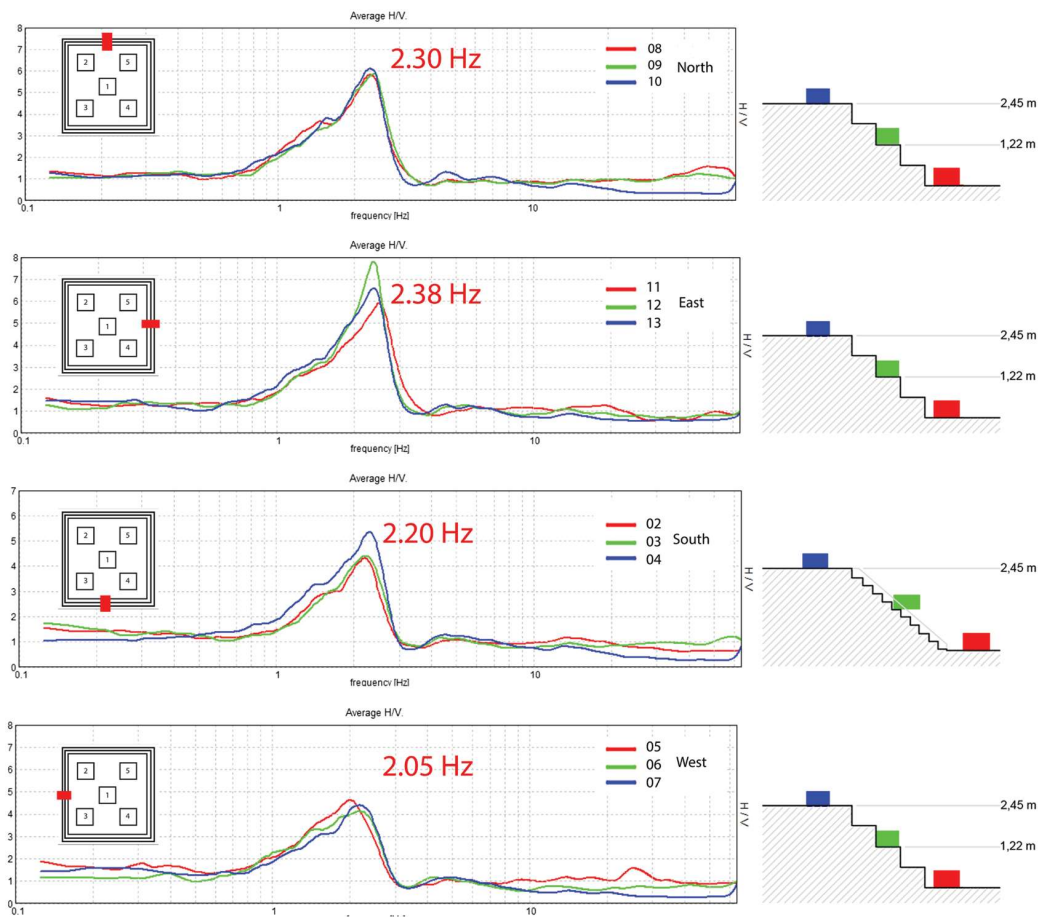
**FIGURE 6** H/V base curves of the Pancha Deval complex

The four H/V analyses, conducted on the four sides of the base, have only one peak that we can consider as the resonant frequency of the ground; the graphs of these analyses are shown in the image below (Figure 6).

It can be observed from Figure 6 that, when the height of the base increases, the amplitude of the spectra increases, except for the East side.

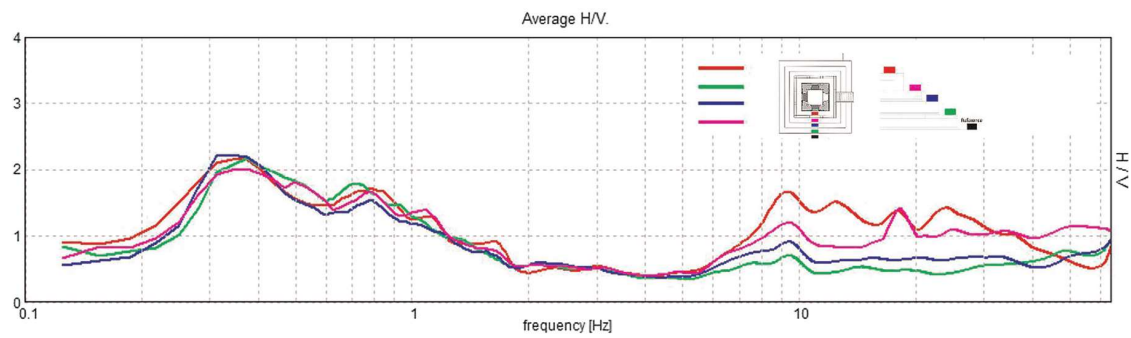
FIGURE 7 H/V base analysis, South-East front of the Radha Krishna temple

The curves obtained from the recordings made on the base of the Radha Krishna temple are more difficult to read because they do not have an identifiable peak (Figure 7). In all the recording on the Radha Krishna base, the curves of H/V analysis have a maximum for frequencies lower than 1 Hz (Figure 7).

This result could be influenced by the presence of a river that flows 15 m from the building, which could be the main source of the low frequency of ambient microtremor.

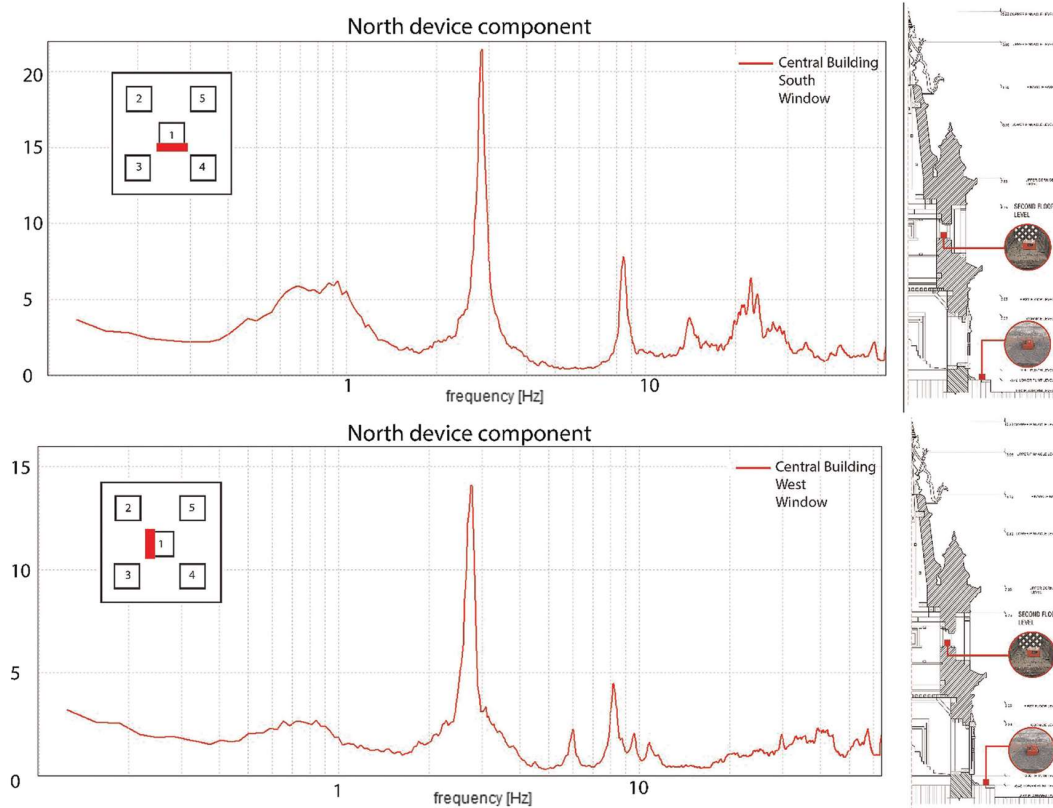
FIGURE 8 Ratio between homologous components, ground and first floor, South and West front, and central building

In the test conducted in the southern fronts of the buildings, it is possible to identify three different natural frequencies. The amplitude of these frequencies decrease with the increase of Hz<sup>41</sup>. This behaviour was generally observed also in the North fronts. The following image shows this trend (Figure 8) and refers to the recording made in the window of the first floor of the South front of the central building.

The East and West fronts present spectra with lower amplitude than the North and South fronts. The amplitude of these frequencies don't decrease with the increase of Hz. The amplitude of the second frequency is smaller than the third, and this could represent a torsion mechanism (Figure 8).

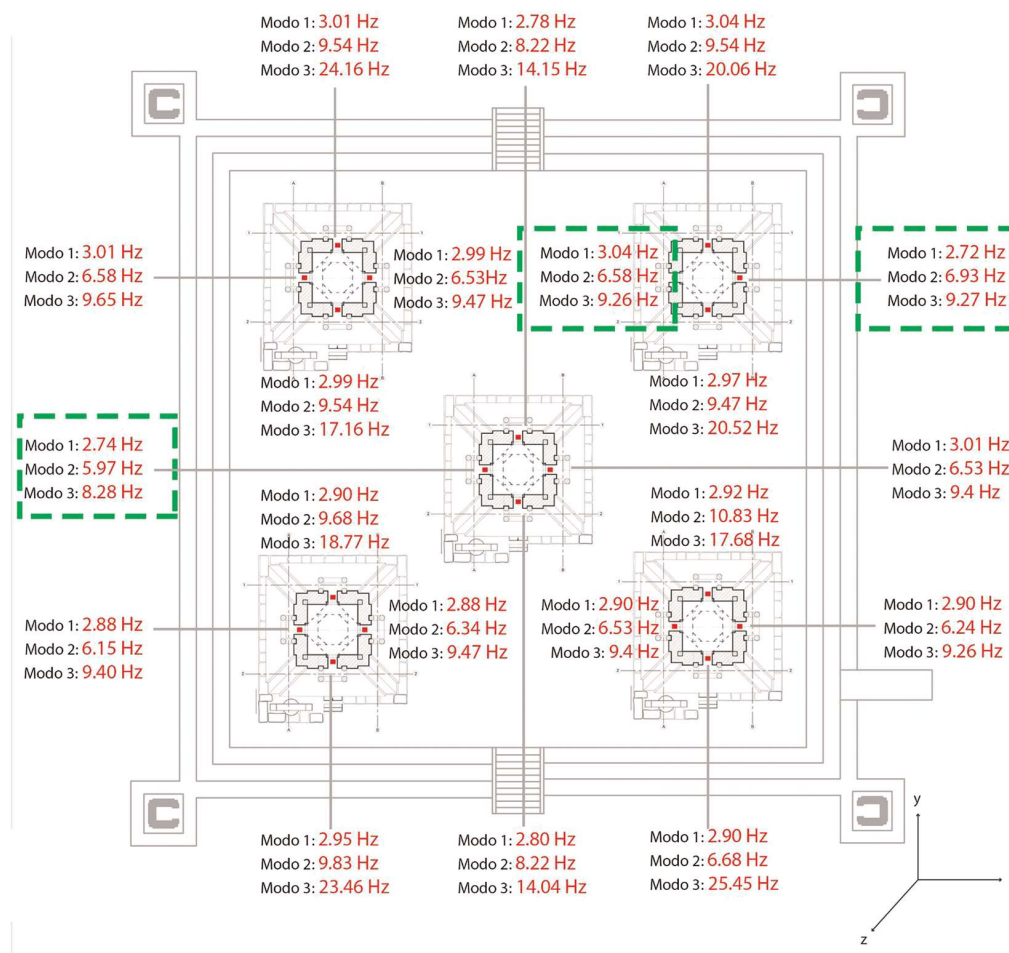
**FIGURE 9** Natural frequencies of Pancha Deval complex (window, first floor). Ratio between homologous instrumental North–South components

Figure 9 shows the SSR analysis of the first local vibration modes (North–South instrumental component). The distribution of frequencies is similar on the different fronts; in green, the lower frequencies are highlighted.

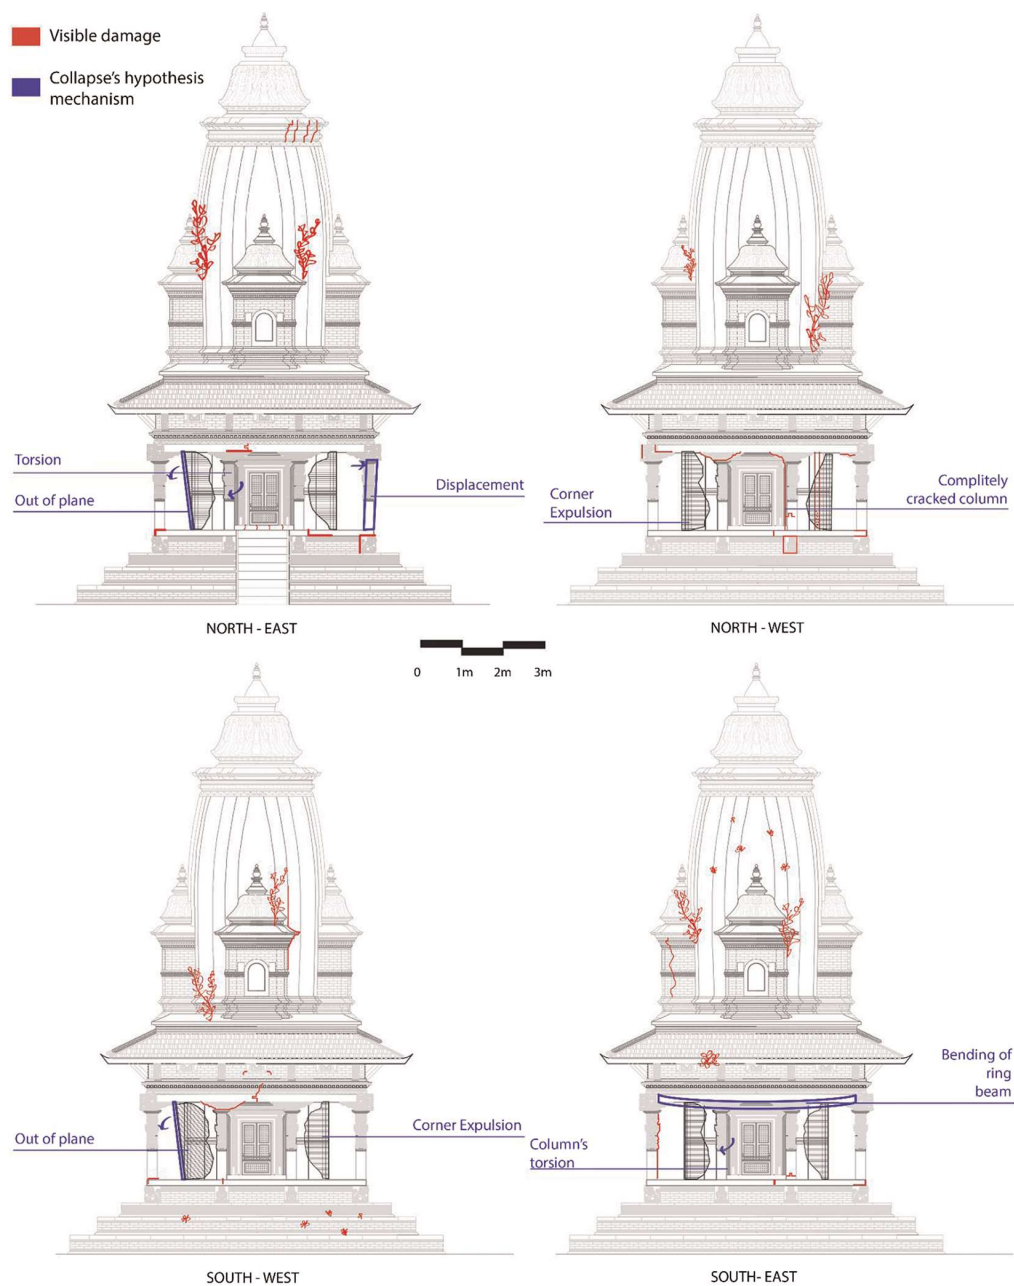
**FIGURE 10** Collapse's mechanism hypothesis, Radha Krishna Temple

During the earthquake, the rigid base, characterized by small periods, transmits the action of the earthquake to the structure that is less rigid and made with low-quality masonry. The masonry responded to the energy transmitted by the rigid support plane with large displacements that triggered the high level of damage. Moreover, we can hypothesize that there is not a homogeneous dynamic behaviour between the base and the structure of the building with consequent major effect of the action of the earthquake.

Visual inspection confirms this hypothesis, and it has been observed that the four masonry corners on the ground floor have collapsed while the base didn't show any damage (Figure 10). The presence of only one horizontal diaphragm

in a 14-m-high structure could have triggered torsion mechanisms with evident damage to the ground floor corners (Figure 10).

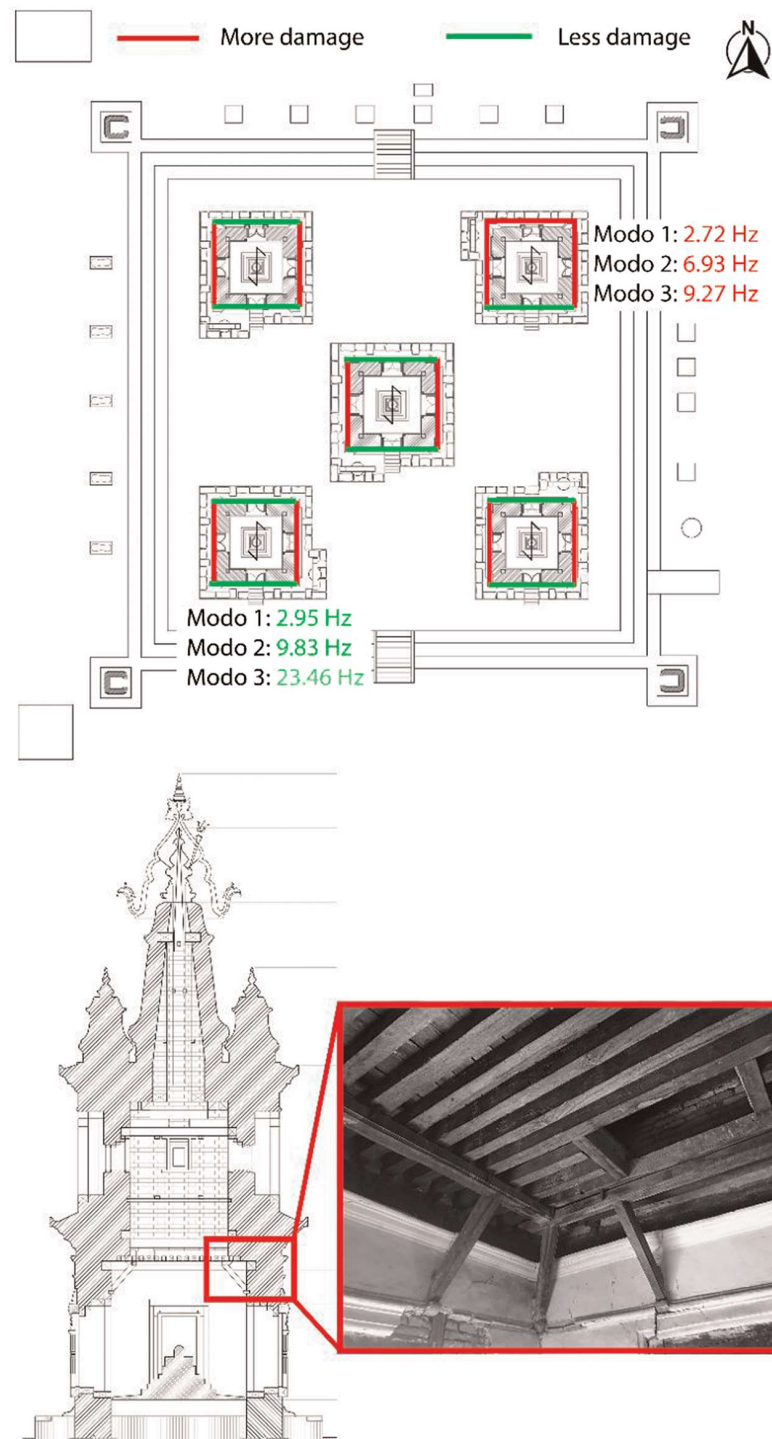
**FIGURE 11** Collapse's mechanism, Pancha Deval complex. (a) Global hypothesis, (b) contribution due to timber elements

The visual inspection conducted in the five buildings of the Pancha Deval complex helps us understand how the masonry's thickness changes near the horizontal diaphragm (Figure 11, red square). In detail, the first floor masonry is thicker than the ground floor. Therefore, the former has a bigger load than the latter and this load is transferred to the

struts, which then transfer it to the ground floor. It has been found that near the base struts, the damage is considerable.

In particular, the North and South fronts, supporting the plane of the beams, are less damaged while the East and West front are more damaged (Figure 11).

The difference in damage between the North–South and East–West fronts is also visible from the outside. The sides not bound by the floor (East and West) have important diagonal cracks on the ground floor.

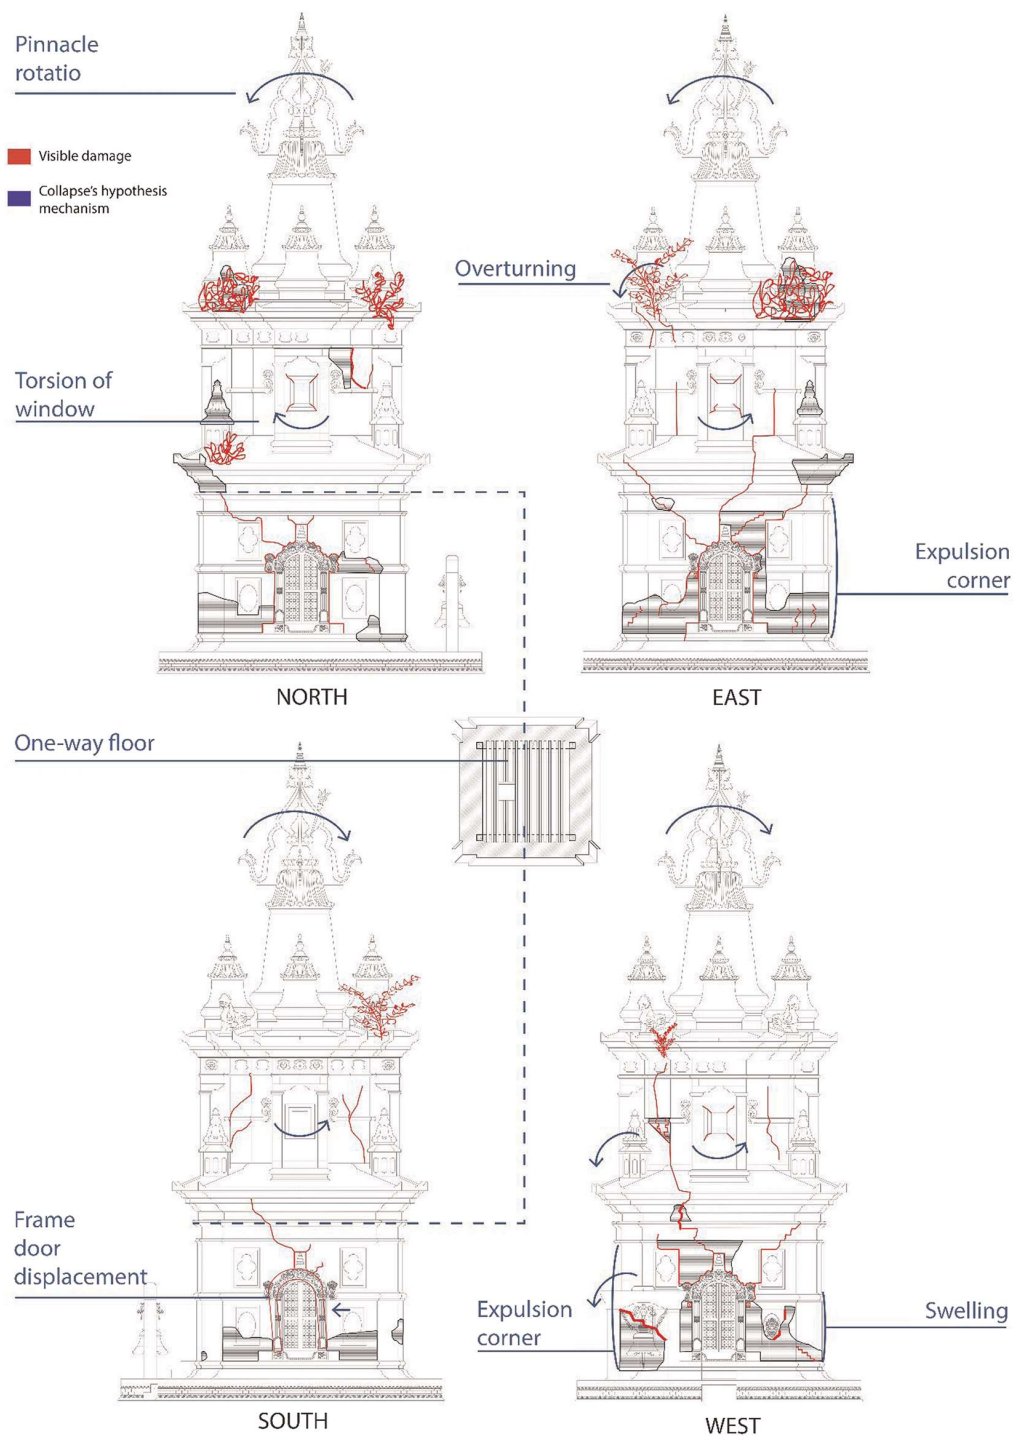
**FIGURE 12** Collapse's mechanism, Pancha Deval complex, North East temple

The framework of windows and stone's door have triggered radial and “X” cracks near the openings due to the difference in stiffness between the stone and the masonry (Figure 12). Other important cracks are visible near the vegetation and near the moulding.

The masonry pinnacles—placed in the four corners of the first level cornice—unload their weight on the corner, weakening the corner and triggering cracks at their base (Figure 12).

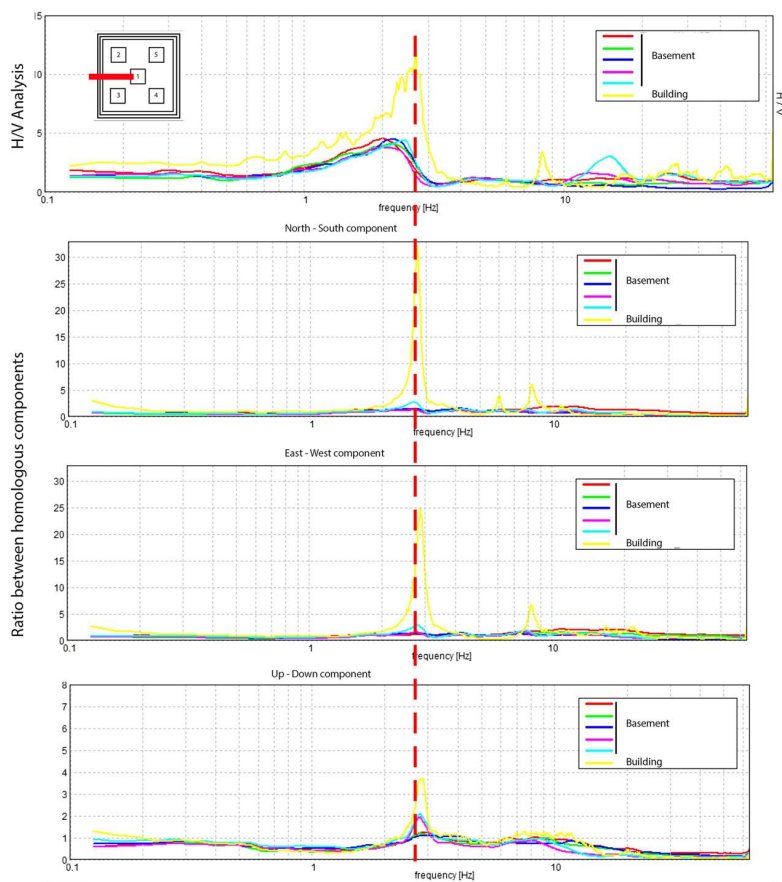
**FIGURE 13** H/V Analysis and ratio between homologous components, side West central Temple

Figure 13 compares the H/V analysis conducted on the West side of the base and the SSR analyses conducted on the West elevation of the central building. The H/V maximum of the base and SSR maximum of the building are in the same frequency range with different amplitudes.

The North–South and East–West curves have a first peak with amplitude greater than the 25 factor, while the up–down curve has an amplitude less than 4.
