Damage Assessment and Dynamic Characteristics of Temples in Nepal Post Gorkha 2015 Earthquake

Eleonora Spoldi & Salvatore Russo

DCP, Dorsoduro 2206, 30123, IUAV University of Venice, Venice, Italy

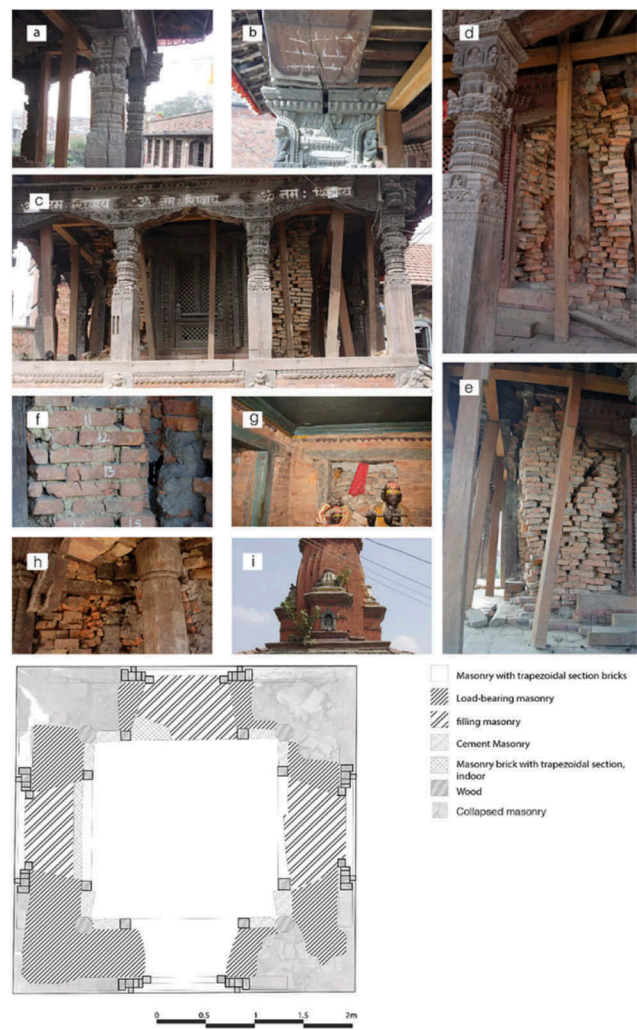
The Radha Krishna temple has an externally undamaged roof, but the masonry on the ground floor has completely lost its static value due to the complete

expulsion of the corners. The roof is 7 m tall, and it has a significant impact, in terms of weight, on the ground floor masonry. The building has not collapsed thanks yet to the wooden colonnade and the timber posts located on each side of the 4 openings. The recent infill of the 4 doors with cement mortar masonry had probably a big role in preventing the full collapse of the structure. The ground floor consists of a timber colonnade that had a good response to the action of the earthquake, although some columns are cracked and some architraves present a horizontal displacement. The structure showed the highest level of damage in the corners. The damage in the piers seems to be related to a lower quality of masonry in the elements. The piers do not show cracks but rather a totally distributed disintegration. The extension of material loss is shown in Figure 3 (damage survey): the corners should be filled with masonry but the hatched areas shows that only a small portion of the original material remains. The damage indicates that cohesion between bricks in the masonry is very low, almost inexistent. It is because of the lack of integrity that the piers suffered severe damage. In detail, it was possible to observe that the colonnade has responded positively to the horizontal stress of the earthquake despite eight columns appear cracked and 4 columns need replacement (Figure 3a, b). The masonry of the ground floor completely collapsed in the four corners, (Figure 3c) shows inside a reinforcement in wood that appear damaged or missing a proper support on the ground (Figure 3d).

The windows are as high as the ground floor and have played a fundamental role in the dissipation of the energy induced by the earthquake. Currently, they present an out of plane mechanism but they are still able to support the completely cracked masonry behind them (Figure 3e). We can assume that the masonry has completely lost its function and the structure is supported by the elements wood (colonnade, architraves, masonry interior columns). The visible mud mortar joints are 1.5–2 cm thick and the bricks have different dimensions and they are not positioned in a regular way (Figure 3f). Successive interventions of punctual consolidation without an overall and unitary strategy are present. Observing the masonry of the ground floor from the inside it is possible to see on each side wooden architrave systems inserted in the walls in correspondence with the external wooden windows (Figure 3g). Also, these wooden reinforcements helped dissipate the horizontal dynamic action. The architraves that make up these systems are inflected and the wall beneath them is cracked. Horizontal reinforcing wooden elements were observed between the architrave systems, placed on the inside face of the masonry, and the

Figure 3. Global and local damage survey of Radha Krishna Temple. a, b) Cracked columns, c) ground floor masonry, d) wooden reinforcement, e) out of plane mechanism, f) masonry detail, g) architrave system inserted in the wall, h) wooden reinforcement detail, i) presence of vegetation as indication of the maintenance absence.

external wooden openings (Figure 3h). The presence of vegetation is also an indication of the maintenance absence (Figure 3i).

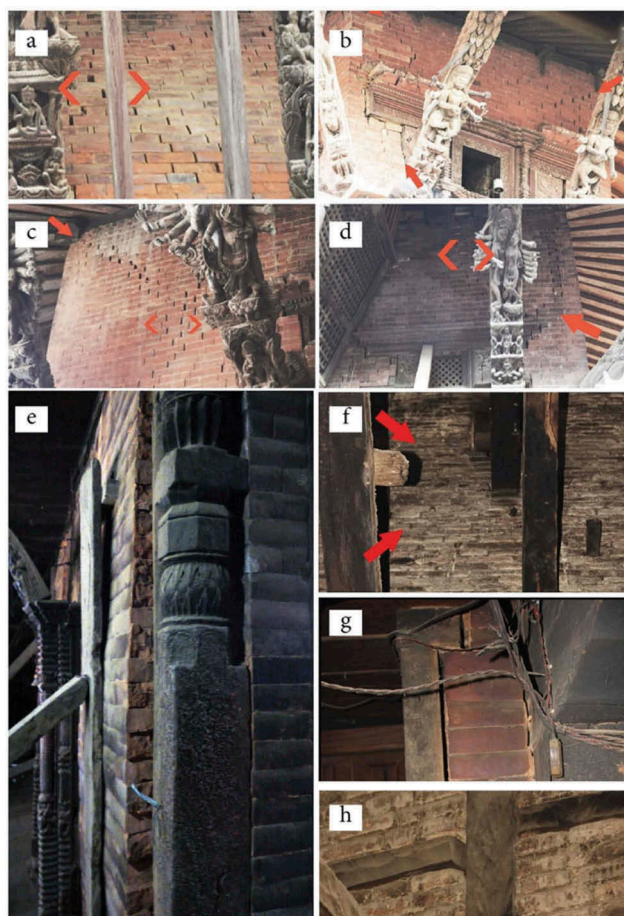
The Bhimsen Temple was slightly affected by the earthquake of 2015 compared to other buildings in Patan Durbar Square. The temple is located on a base that has not reported any damage and overall the structure has been slightly damaged but it is not about to collapse. Globally, the most obvious damage is visible at the point of contact between wood and masonry elements. This is influenced by the different vibrating way of these materials and their elastic characteristics. According to the external visual inspection, the temple presents diagonal cracks that end in the direction of the wooden frames or at the point of contact wall-floor-roof. Lateral sliding of the bricks near these cracks is also

visible. More specifically, there are diagonal cracks with a horizontal sliding of the bricks. (Figure 4a). This type of cracks are visible at the point of contact between wood and masonry in all building levels. There are twice cracks visible around the wooden windows, and in addition to the cracks, a detachment is visible between the timber and the masonry, caused by the difference in strength and elasticity of the two materials and by the presence of a vacuum in the masonry (Figure 4b). Some corner expulsions, with diagonal cracks, are mainly visible on the second floor. The cracks are visible along the mortar joints and no cracked bricks are visible. It must be remembered that this type of brick is used as a covering and it is not possible to view the real condition of the load-bearing masonry (Figure 4c). The Figure 4d still shows a diagonal vertical crack along the mortar joints, at the clamping point of the corner, probably caused by an incorrect position of the corner bricks. If on the outside the visible damage is limited to some cracks, the damage level of the internal structure is much higher. The Figure

Figure 4. Global damage survey of Bhimsen Temple. a) diagonal crack, b) twice crack, c) masonry detail, d) vertical crack, e) masonry swelling, f) top floor crack, g) Wooden and masonry detachments, h) separation between timber pilaster and timber beam.

4e shows an evident masonry swelling (about 10 cm) with frame detached. This damage is relative to the wall on the first level. Important cracks along the mortar joints are visible on the top floor (Figure 4f). There are also some detachments between wooden and masonry portals (Figure 4g). Figure 4h shows the separation between the timber pilaster and the timber beam, inserted in the masonry of the last level. The northern façade is the most cracked elevation and the damage reported included twice cracks on the first floor, diagonal cracks and lateral sliding of the bricks on the second floor, separation between the masonry and wooden the windows.

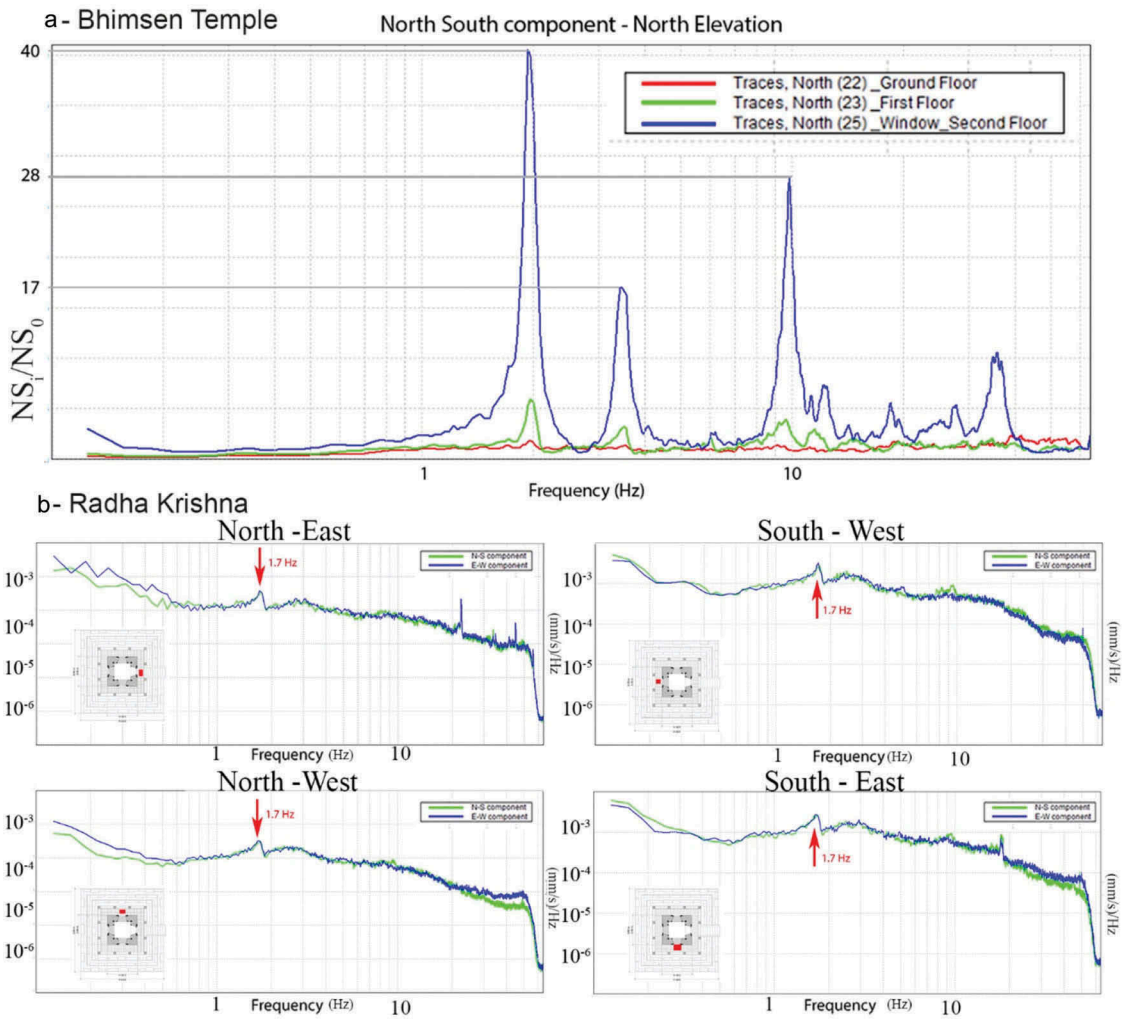
In the case of the Radha Krishna temple, where it was not possible to place the device in the building, the Fourier amplitude spectra of velocity (device placed on the base) shows a peak. This cannot be a ground peak because it would present a different form, for example an ogive form, so we can hypothesize that the peak is the first frequency of the temple (Figure 5b).

Figure 5. A) Ratio between homologues component, Amplitude, North front, Bhimsen temple B) Fourier amplitude spectra of velocity, Radha Krishna Base.

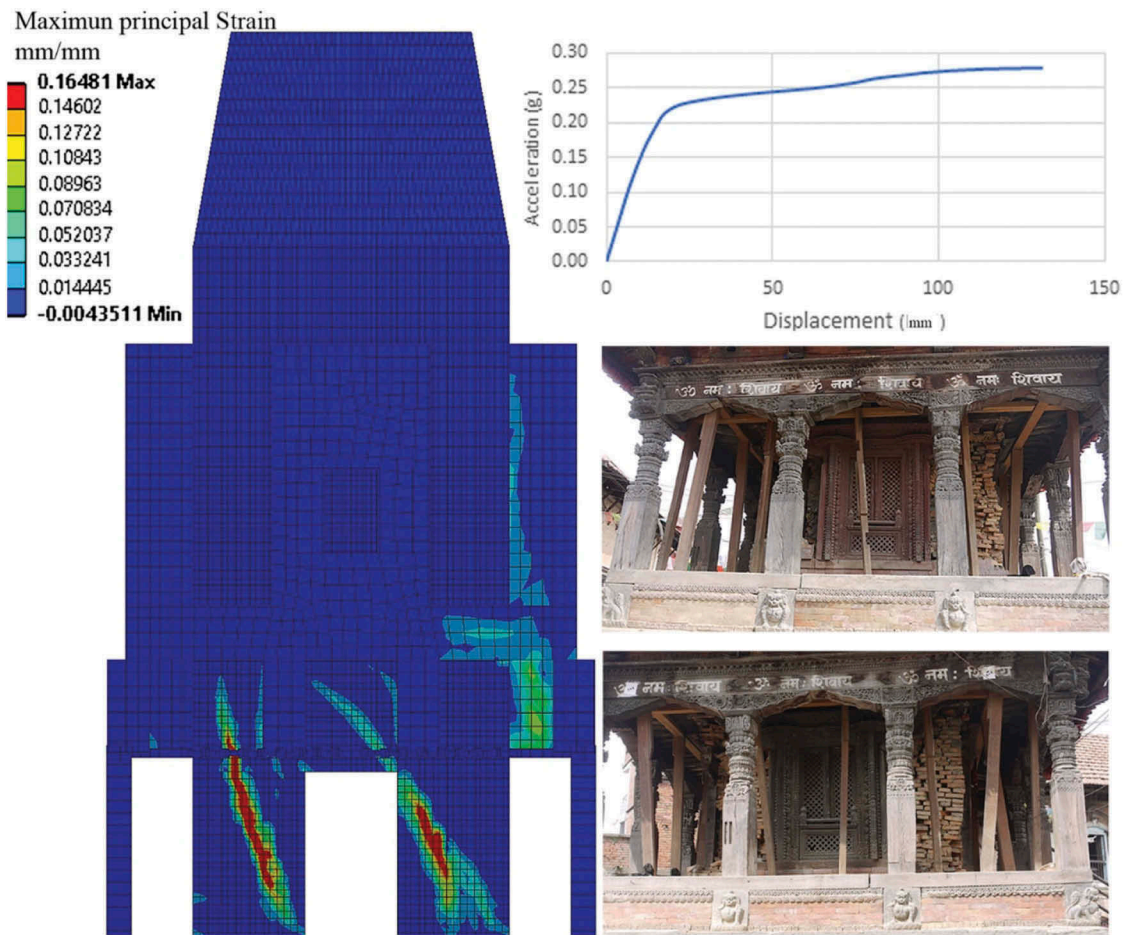
For the Radha Krishna case study, a load of 0.5 g was divided in 300 increments of 0.001667 g and it was applied in X direction. The Radha temple is symmetric in both horizontal and vertical axis, so the load was applied only in one direction. The chosen control point is the top point of the structure. The amount of deformation produced by an equal load increment remains the same at the beginning of the load stage (elastic range), however the appearance of cracks (nonlinear range) decreases the strength of the walls which results in a higher deformation. This phenomenon continues until the level of deformation in the building becomes too high (the walls have greatly weakened because of the accumulated damage). As shown in Figure 9, the Radha Krishna Temple would have a severe amount of damage (close to collapse) if hit by a 0.26 g earthquake. The last large Gorkha earthquake event had a maximum magnitude of 0.16 g and resulted in significant damage in the building. Numerical analysis shows also important shear cracks (Figure 9, maximum strain). These cracks are mainly developed on the ground floor.

In the real situation, when the temple was hit by the Gorkha earthquake, it did not develop important cracks but the masonry was simply disintegrated as if there were no mortar to connect the bricks. The Figure 9 shows a comparison between the maximum principal stains (numerical model) and the real damage. The value of 0.16481Max is very high for masonry, we remember that the model is related to virtual beam-masonry composed material with perfect bound between them.

Figure 9. Principal strain, capacity curve and masonry details of the Radha Krishna temple.

According to the pushover curve the capacity of the Radha Krishna temple with no additional reinforcement is of approximately 0.26 g. At this level of load, the curve has already started to show a nonlinear behaviour. The maximum principal strain shows a high level of damage comparable to the real situation.

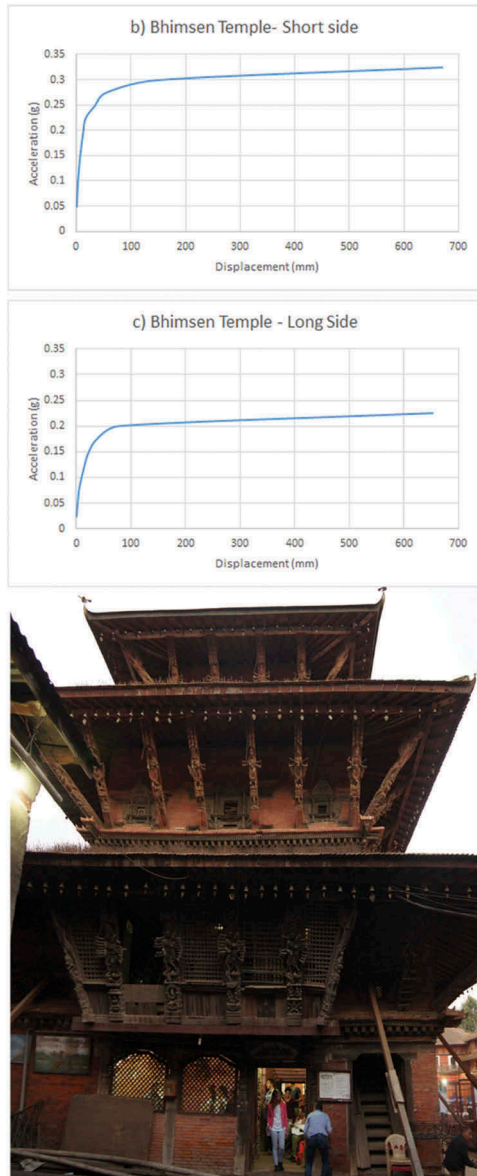
In the Bhimsen temple model, a load of 0.5 g was divided in 300 increments of 0.001667 g and it was applied in X direction and Z direction. The capacity curve (Figure 10) shows that the building is close to collapse at 0.3 g in the Z direction, while in the X direction this occurs at 0.23 g.

Figure 10. Principal strain, capacity curve and masonry details of the Bhimsen temple.

The capacity of the Bhimsen temple, according to the pushover curve, is of approximately 0.23 g (short side) with 140 mm displacements max and of 0.2 g (long side) with 600 mm displacements max.
