## Journal of Cultural Heritage

## Case study

## Church of San Pietro Martire in Verona: A conservation-oriented approach between historical and structural interpretation

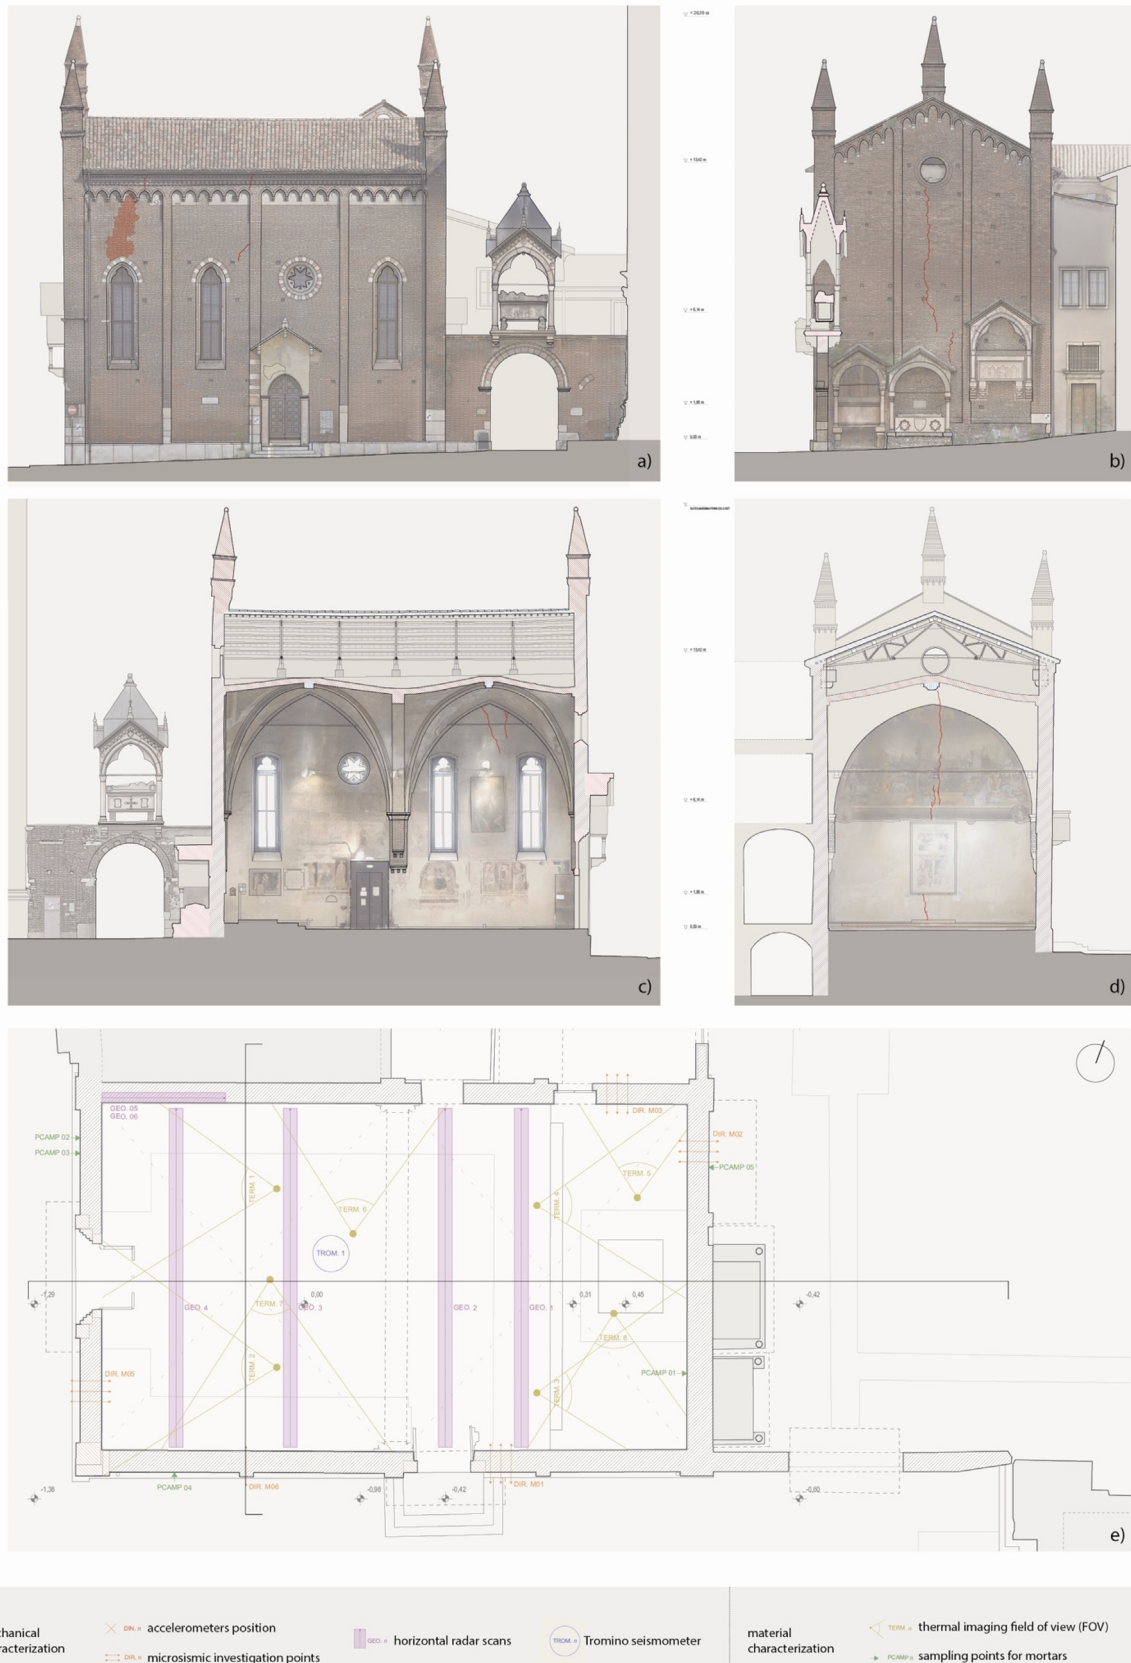
*Crack SO* (Fig. 1a) is characterised by a diagonal fissure located in the upper portion of the south façade, oriented towards Piazza Santa Anastasia (Fig. 2). The phenomenon is associated with a broader process of surface spalling, leading to the localised detachment of lithoid material from the external masonry. Internally, this deterioration corresponds to a network of micro-cracks observed at the junction between the wall and the masonry vault. From a structural standpoint, this crack pattern is compatible with an out-of-plane bending mechanism of the south wall, induced by the horizontal thrust of the adjacent vault and favoured by the geometric slenderness of the wall–vault system.

*Crack EV* (Fig. 1b) is observed in the eastern masonry and presents as a vertical fissure. This structural discontinuity is centrally located on the façade, originating at the springing point of the attic oculus and extending downward to the arch of Leonardo da Quinto (one of the Scaliger tombs located in the external front), which is connected to the base of the wall [28]. On the interior side, the crack intersects with the allegorical fresco of the Annunciation attributed to Giovanni Maria Falconetto (1514) [29], descending towards the base of the masonry and adversely affecting a portion of the adjacent vaulted structure. This phenomenon indicates potential weaknesses in the structural integrity of both the masonry and the fresco, warranting further investigation. Unlike *Crack SO*, the geometry and orientation of this discontinuity do not indicate a thrust-related or overturning kinematic, but are instead consistent with a localised stress redistribution mechanism, likely associated with stiffness discontinuities induced by later construction phases. This interpretation points to a damage pattern gov-

**Fig. 1.** Università Iuav di Venezia, 2024. *Integrated Geometric Survey and Characterisation of the Crack Pattern.* (a) South elevation showing the Crack SO and previous scuci-cuci repair areas; (b) East elevation showing the Crack EV; (c) Longitudinal section of the church; (d) Transversal section; (e) Ground-floor plan with the location of the diagnostic investigations, including ambient vibration testing, microseismic measurements and thermographic surveys.

larities in the masonry affected by the *Crack SO* system and the adjacent vault's webbing. Fig. 1 provides the geometric framework for the experimental results, correlating crack patterns, building morphology and the spatial distribution of investigations. The south façade macro-element affected by the crack system is clearly identifiable in elevation and section, allowing the localisation of the out-of-plane deformation field subsequently quantified through point-cloud processing. Likewise, the east façade macro-element associated with the East façade vertical settlement crack is explicitly framed within the building geometry, enabling the verification of its current vertical alignment and the absence of measurable out-of-plane displacements.

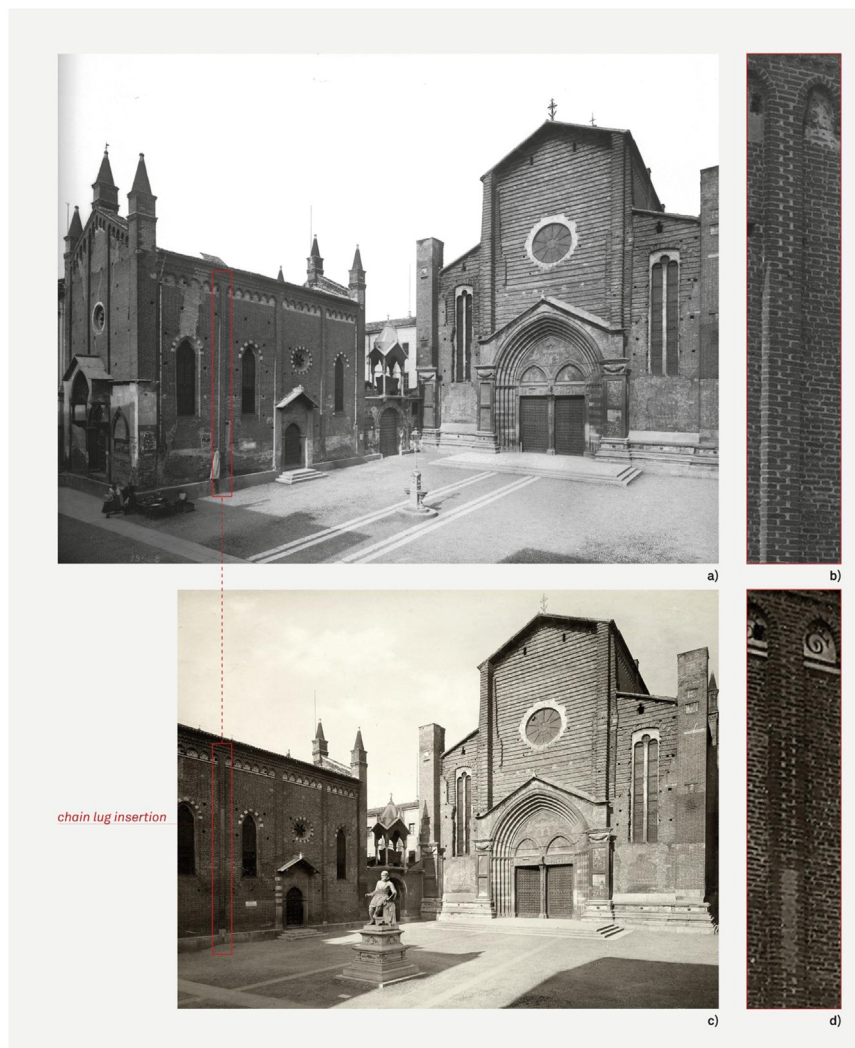
About Fig. 2, archived within the Alinari collection, an examination reveals the conservation status of the façade facing St. Anastasia Square as documented in 1900, immediately following the reconstruction of the church roof. Newly implemented masonry restoration interventions remained confined to the localised area affected by *Crack SO*. These interventions exhibit noticeable variations in the colour of the added bricks and differences in the size of the mortar joints. In the earlier photograph (Fig. 2a), the traces of the chain lugs associated with the pilasters are absent. In contrast, the picture taken a decade later (Fig. 2c), dated between 1915 and 1920, clearly shows these features. By comparing these photographs with the current state, it was possible to deduce that the bulging wall mechanism was already operational at that time. The reconstruction of the roof structure using steel trusses, installed in 1965, as documented in the executive project in the AgVr archives [AC.8], represents a subsequent intervention following the emergence of structural issues. This modification can be interpreted as reinforcing the structure in response to identified damage in the affected section.

**Fig. 2.** View of Piazza S. Anastasia. Historical comparison over a twenty-year period from 1900 to 1920: (a) *The churches of S. Anastasia and S. Pietro Martire in Verona (c. 1900)*, Alinari Archives, Florence, Alinari Archive, ACA-F-012680-0000; An area rebuilt using the scuci-cuci technique is visible above the first window; (b) a detail of the same photo showing the external wall without traces; (c) *View of the churches of S. Anastasia and S. Pietro Martire in Verona. The monument to Paolo Veronese is visible at the centre of the square. 13th – 15th centuries. Brogi, c. 1915–1920*, Alinari Archives, Florence, Alinari Archive, BGA-F-013164-0000; (d) a detail of the same photo showing the external wall with the traces of chain lug insertion.

The orthophoto of the south façade also highlighted masonry portions rebuilt through *scuci-cuci* interventions (Fig. 2a), associated with the insertion of tie-rods and otherwise difficult to identify through direct visual inspection. The analysis enabled the identification and quantification of different repair campaigns implemented over the last two centuries in the affected pilasters, also documented in the historical photographs, as attempts to restore the continuity of the wall structure. The temporal stratification of these interventions, combined with the use of different materials, has resulted in a heterogeneous conservation condition of the masonry joints and repaired areas. The discretisation of the structure into macro-volumes [32] therefore supports the interpretation of a confined out-of-plane bending mechanism, aggravated by the poor cohesion of the wall face and by the horizontal thrust exerted by the deformed vault.

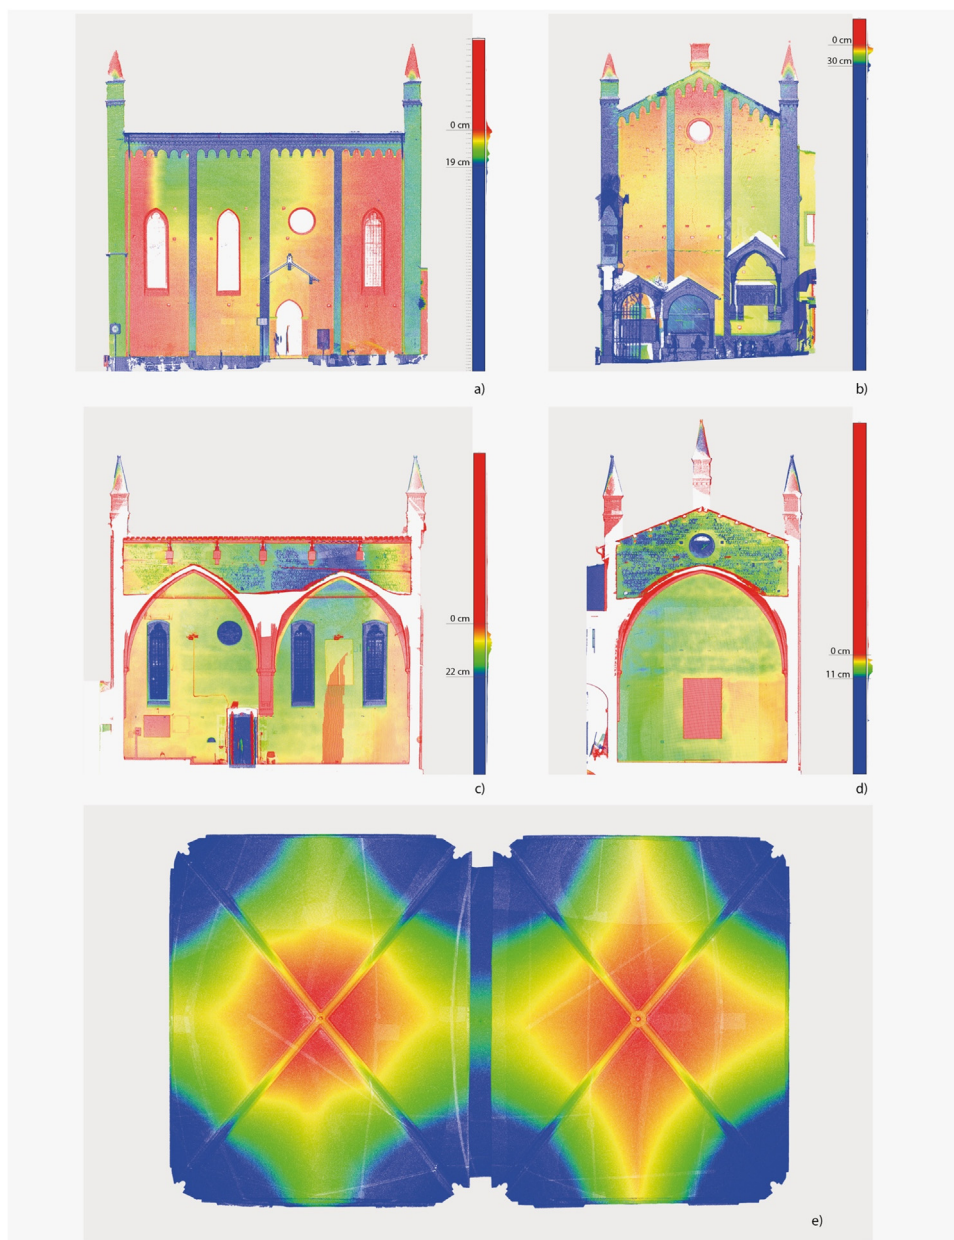
A comparable methodology assessed the geometric deformations of the interior vaults. The findings indicate that the vault associated with *Crack SO* demonstrates downward displacement at its interface with the adjacent masonry, thus corroborating its function as a thrusting component within the structural framework (Fig. 3e).

**Fig. 3.** Università Iuav di Venezia, 2024. TLS-derived deviation maps of the masonry façades and vaulted system. (a) South elevation; (b) East elevation; (c) Longitudinal section; (d) Transversal section; (e) Vault intrados deviation map. Colour gradients represent the measured deviations from the reference geometric planes derived from point-cloud processing.

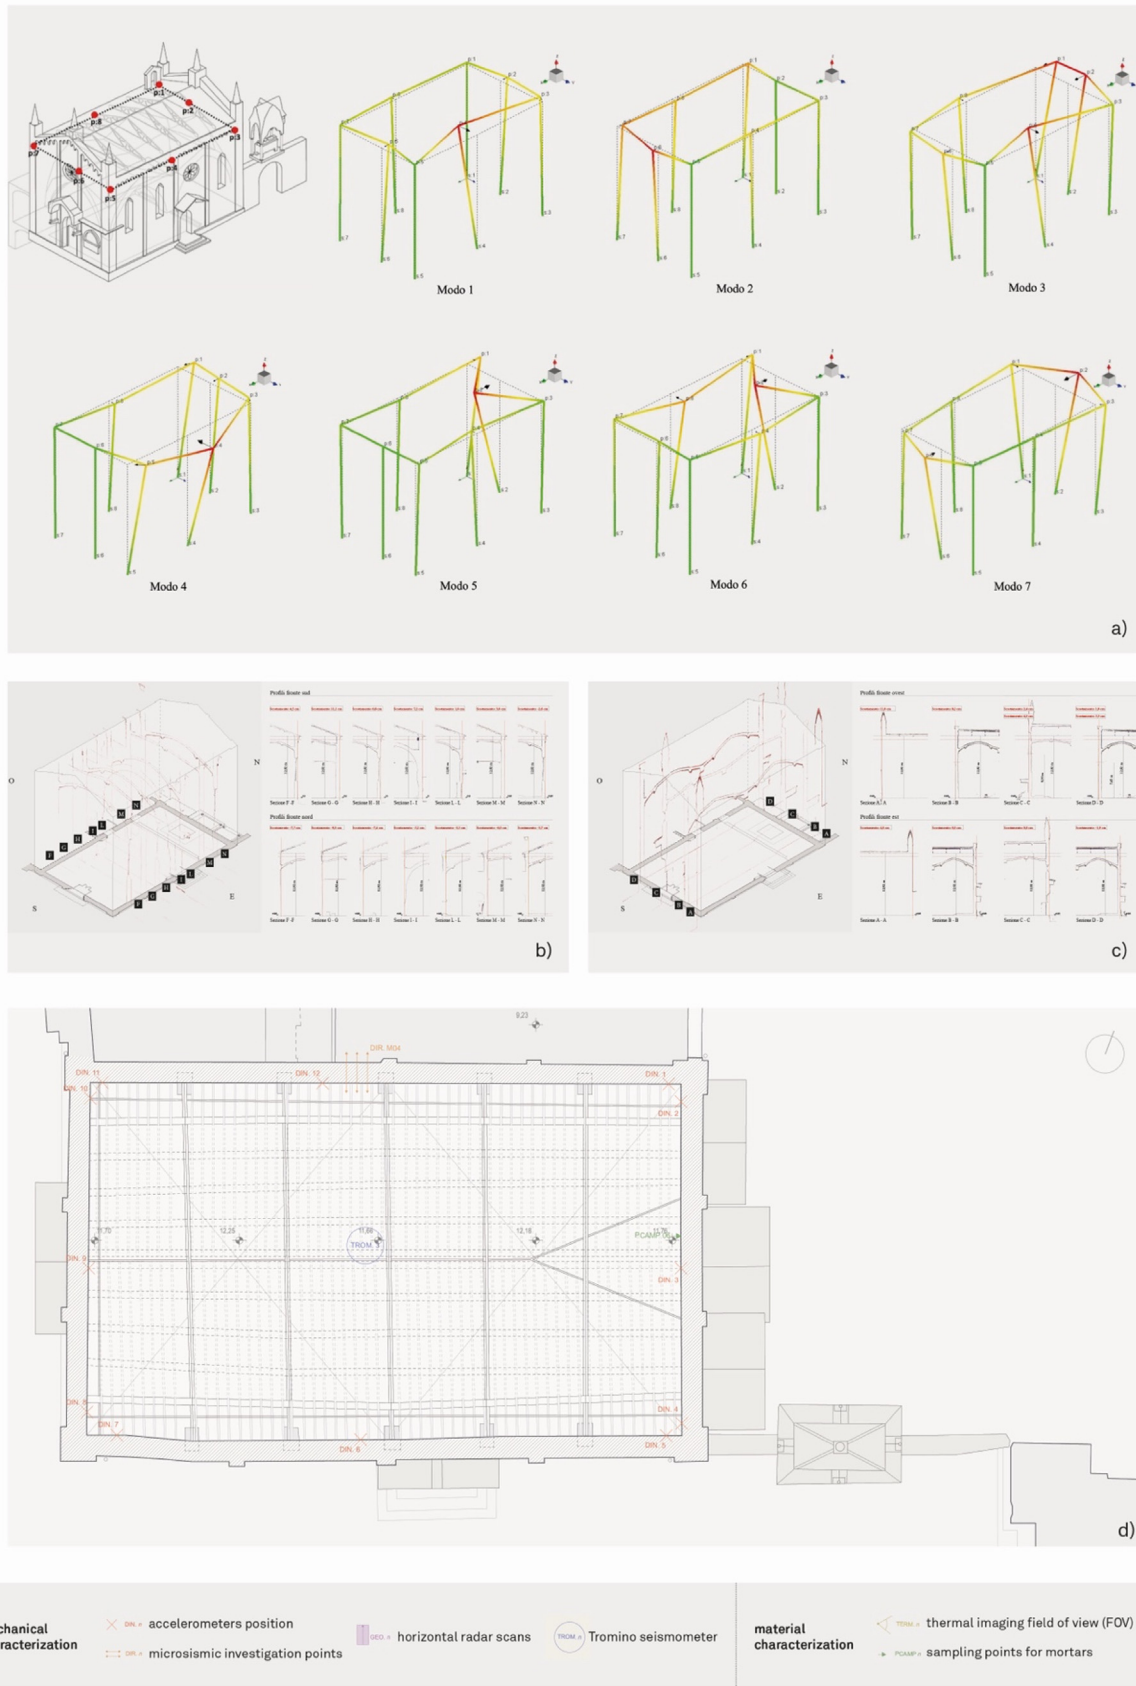
**Fig. 4.** Università Iuav di Venezia, 2024. Correlation between modal shapes and geometric deformation profiles. (a) Principal vibration modes and sensor layout derived from ambient vibration testing; (b) South façade deviation profile obtained from TLS processing; (c) East façade deviation profile; (d) Plan-view distribution of the investigation points and measurement locations.

Global monitoring using dynamic identification techniques detected the potential development of kinematic responses associated with *Crack SO* and *Crack EV*. Fig. 4 correlates the experimentally identified modal shapes with the geometric deformation profiles obtained from TLS processing. The figure therefore supports the comparison between dynamic vulnerability and measured displacement fields. Mode 1 deformation, activated with frequency 4.26 Hz, underlines potential out-of-plane tilting mechanisms of the south wall, characterised by *Crack SO*. Vibration modes 3 and 4, 12.42 Hz and 15.29 Hz, respectively, activate both the South macroelement (*Crack SO*) and East one (*Crack EV*).

The East macroelement exhibits behaviour influenced by a torsional mechanism induced by the adjacent structure. The same analyses suggest that the wall of the South elevation is subject to horizontal bending caused by the local overhang corresponding to

*Crack SO*. It describes the current geometric condition of the element and, therefore, identifies a kinematic mechanism already active. Modes 5, 6 and 7 highlight the vulnerabilities related to the east and west fronts, qualitatively returning the greater instability of the east front, characterised by *Crack EV*.
