# A Proactive GIS Geo-Database for Castles Damaged by the 2012 Emilia Earthquake

**Abstract:** The 2012 Emilia earthquake highlighted the vulnerability of fortified architecture. Based on the observed seismic behaviors, this research proposes a GIS geodatabase, designed with a proactive approach, for the prediction and prevention—at a territorial scale—of the most frequent damage mechanisms of the investigated typology. The designed geo-database allows for the identification of possible correlations between constructive features and the occurrence of damage, through statistical and geo-referenced analysis. Moreover, the designed geodatabase, by enabling the comparison of the damage level data with the seismic action of the site, through INGV (National Institute of Geophysics and Volcanology) shakemaps, allowed the definition of experimental fragility curves, for three of the most common damage mechanisms. By applying these functions to castles in the province of Parma, it was possible to define future seismic risk scenarios for the mechanisms considered, thanks to the use of the seismic hazard map. Therefore, the described methodology could be functional to identify the most urgen

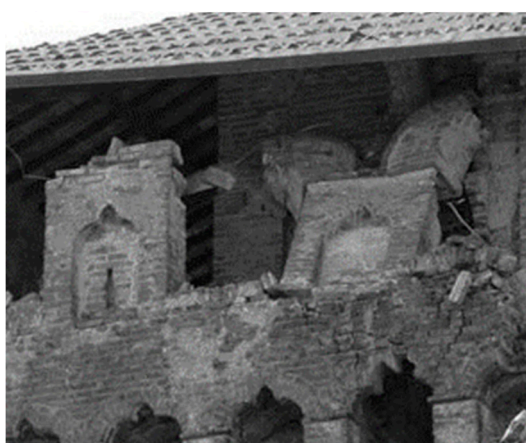
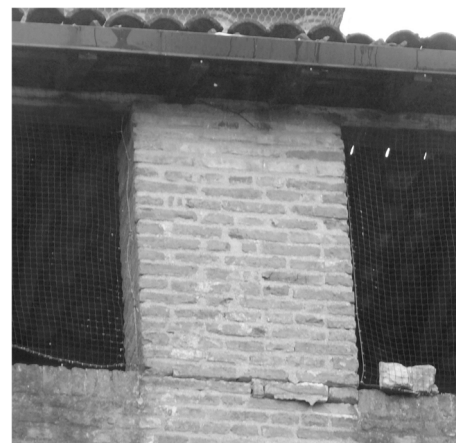
**Figure 9.** Two examples of overturning of the merlons with roof: **(a)** merlons of a tower of the Castle of Finale Emilia; **(b)** a merlon of the curtain walls of San Felice sul Panaro Castle.
