# Seismic damages on fortified architectures: Lessons learned from three earthquakes (Emilia 2012, Central Italy 2016, Albania 2019)

*Department of Engineering and Architecture, University of Parma, Parma, Italy*

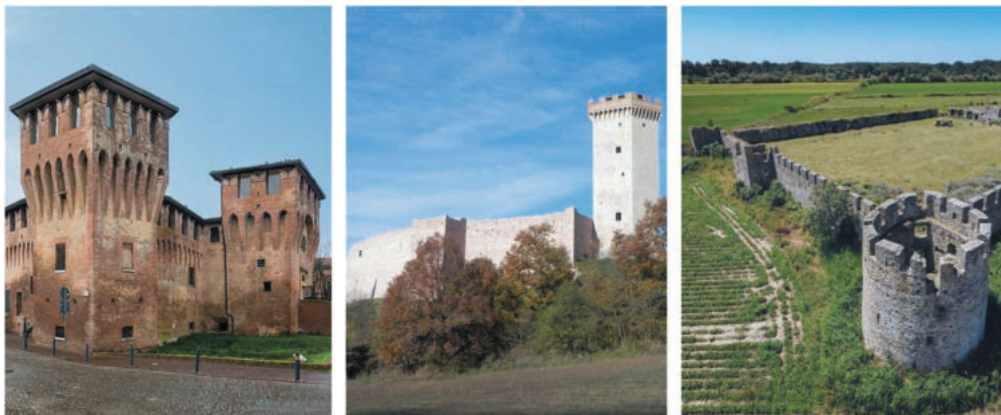
Figure 2. Three castles instantiating the general features of the three analysed regions. From the left: Rocca di Cento (Emilia), Castello di Capodacqua (Central Italy), Bashtove Castle (Albania).

The morphological aspect of Albanian castles is quite different from the Italian ones. Indeed, in general, Italian castles, even if they start with towers and walls surrounding an inner court, tend to fill in this court in time with palace-type buildings. This evolution follows an evolution in the use of these buildings, that were often transformed into residences after the 16th century, when the introduction of artillery made them unfit to stand military assaults. On the contrary, Albanian castles are still composed, in most cases, by wall enclosures and protruding towers and are usually devoid of palaces (Figure 2). For the Italian castles, the presence of these palaces, often added without an effective connection with the pre-existing walls, are a typical element of seismic vulnerability.

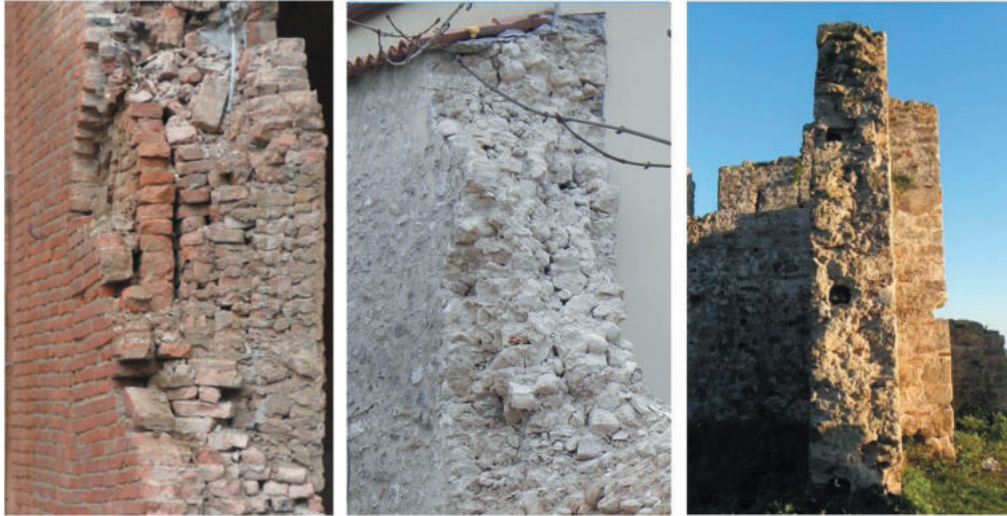
Figure 3. Instantiating cross sections of walls. From the left: Rocca di San Felice sul Panaro (Emilia); Norcia curtain wall (Central Italy); Bashtove Castle (Albania).

The materials traditionally used for construction in the three analysed geographical areas are not homogeneous, but they vary depending on the orographic conditions in which the single artifacts were built. In general, the buildings in alluvial planes, in Emilia but also in certain parts of Central Italy and of Albania, are usually built in clay bricks masonry, while the ones on the hills and mountains are generally in stone, with various shapes, dimensions and textures. In Emilia the masonry is often thick but composed of three leaves: the two external ones of good quality, but often not well connected, and the internal part made of a mixture of poor mortar, bricks and cobblestones (Figure 3).

the castles outside of town were built in the Middle Ages. The first ones are characterized by a high quality masonry, mostly in bricks, and in particular by a mortar with hydraulic properties and high strength. The latter are instead mostly in stone (also Bash-tove, which is in a plane), with a more disordered texture and with a poor mortar, with a low quantity of binder.

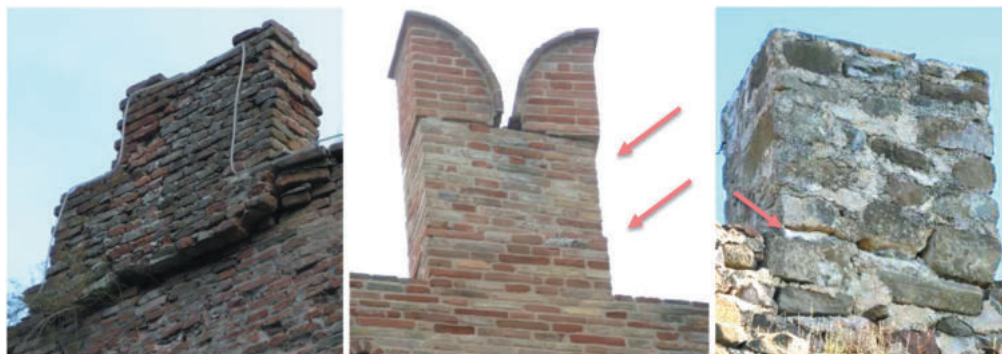
The damage mechanism activates with the out of plane rotation and/or the slipping of the merlon or part of it. The crack pattern is characterized by a horizontal crack indicating the creation of a sliding plane, generally at the base of the merlon itself (Ferretti et. al 2018; Lenticchia et al. 2018) (Figure 5). The cases in which a roof structure was added over the merlons were less subjected to this damage mechanism, as in some way the roof structure became a constraint and applied a vertical, stabilizing force, while the merlons which were free at the top were more vulnerable. In some cases, metal bars were inserted in the past between the merlons and the underlying masonry: this usually limits the risk of overturning or sliding, but it can induce stress concentrations at the interface, causing local damages in the masonry (e.g. in San Felice sul Panaro main tower). In general, the more the merlons are slender and placed in a high position, the more the activation of this mechanism is probable: e.g. merlons in

Albanian castles were in most cases quite squat and only in one case (Preza Castle) were subjected to overturning, while Italian merlons from the gothic revival period (end of the 19th century) often collapsed due to their high slenderness and limited connections, as they were built only as decorative elements.

Figure 5. Overturning of the merlons. From the left: Reggiolo Castle (Emilia); Rancia Castle (Central Italy); Preza Castle (Albania).

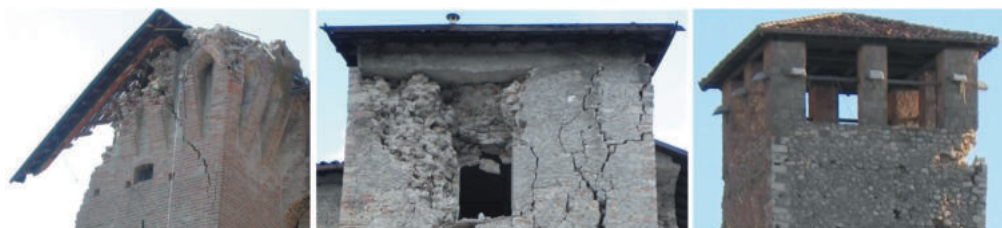
This damage mechanism activates for in plane shear deformations, due to a horizontal sliding. The consequent crack pattern is composed by horizontal cracks along the mortar joints, with the sliding of the roof structure over the underlying masonry. Good quality lintels over the windows and good connections between masonry and roof elements contribute to improve the behaviour. On the other hand, the presence of heavy and stiff roof structures, like reinforced concrete beams, can trigger and favour the development of this mechanism.

Figure 6. Shear collapse of the roof structures in San Felice sul Panaro Castle (Emilia); Tower of Norcia curtain wall (Central Italy); Kruja Castle (Albania).

Unfortunately these incongruous elements were often inserted during the 20th century, with the idea of limiting the decay phenomena with respect to the timber elements, but nowadays it is clear that their negative effects in terms of seismic vulnerability are often higher than the possible positive ones. It is therefore very important to spot these elements through a thorough survey and historical analysis in order to identify in advance this potential problem.
