Full scale test on reinforced concrete elements of an existing bridge: on-site investigation and laboratory testing design

2. The 'Fratta' bridge

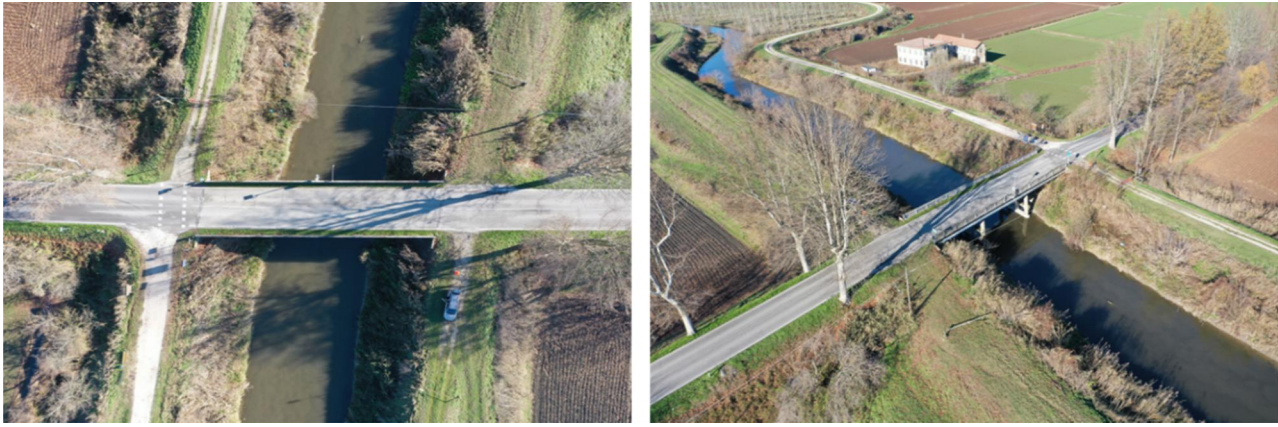
Figure 1. Fratta bridge (Italy): aerial views obtained with the drone survey.

The 'Fratta' bridge is located in the northeast of Italy near Piacenza d'Adige, Figure 1. The bridge crosses the Fratta River with an angle of inclination of approximately 10 degrees, so producing a skewed geometry of the bridge deck. As frequently occurs in the case of old bridges, there is a lack in available documentary information, and the structural project of the bridge is unavailable. Only few original drawings have been found, some of them are depicted in Figure 2. As indicated by the project cover page, the bridge was designed in 1948. The limited availability of historical data (lack of project details, drawings, and calculation reports) makes it essential to plan a thorough campaign of tests and investigations with the aim of acquiring a sufficient level of knowledge of the bridge. One of main aims of the ongoing research project led by the University IUAV of

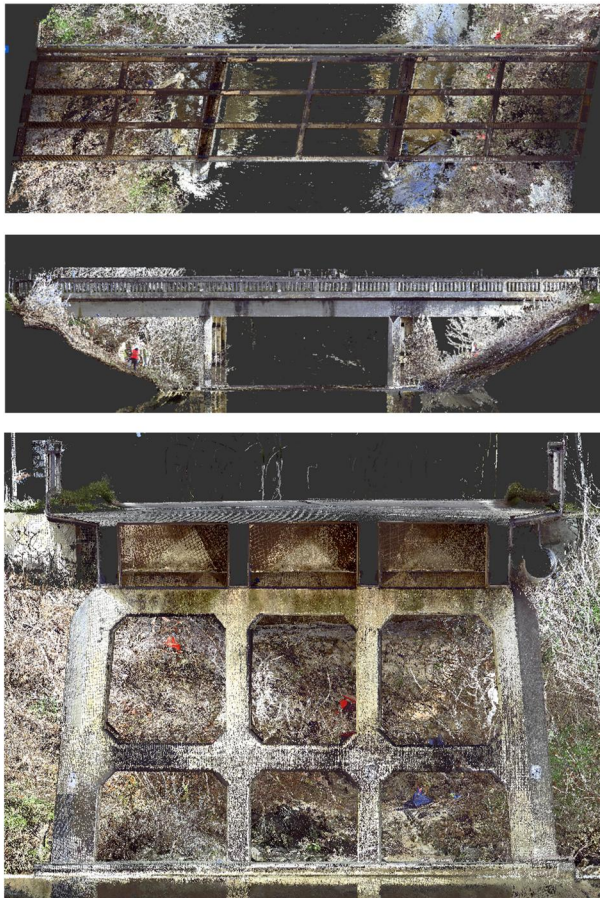
Figure 3. (a) Top view; (b) lateral view; (c) cross-section of the Fratta bridge.

The geometry of the bridge was obtained through a detailed laser-scanner survey combined with traditional on-site measurements. The Fratta bridge is constituted by three structurally independent cast on-site RC decks, featuring three simply supported spans, each spanning 12 m. Each span, with a width of 8.10 m, consists of three 1.0 m high beams supporting a 20 cm thick concrete slab. Equidistant RC transverse beams connect the longitudinal girders, with one positioned at the center and two at the ends. The height of the central transverse beam is the same as the longitudinal girders, while the height of the end ones is about 20 cm smaller, to leave the space in height for the supports. The bridge deck is supported by fixed lead sheet bearings. In the riverbed, the piers rise to a height of 5.00 m and are constituted by two RC frames each in the upper part.

The structural joint between the frames (and consequently between the decks) measures approximately 2 cm, serving to accommodate thermal deformations of the span. The abutments, standing at a height of 2.80 m, feature rear and wing walls that incorporate the approach embankment. Piers and abutments foundations are pile driven, although specific details are currently unavailable. Some examples of the geometrical survey outputs are depicted in Figure 3, where the plan, the lateral view and a transversal cross-section of the bridge are represented. Next to the geometrical drawings, the corresponding images obtained from the laser scanner survey are also reported.

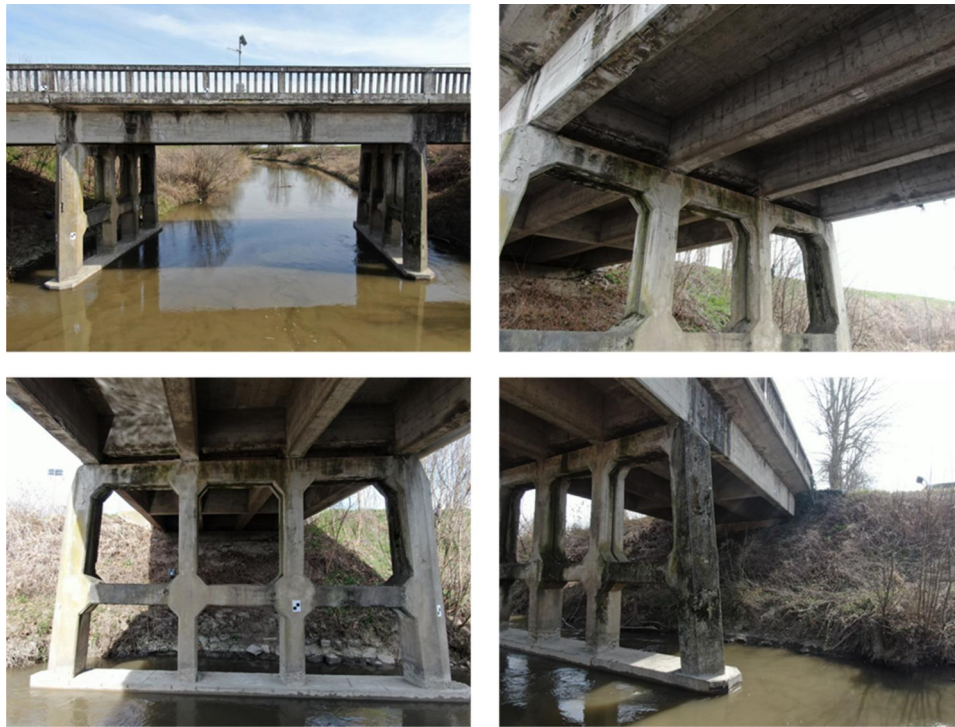
Figure 4. Photos obtained by the drone survey.

In addition, a drone survey was carried out. Surveying with a drone allows to acquire photos of parts of the structure that are not visible or directly reachable by the classical laser scan technique (e.g. parts above the watercourse, supports). It is worth noting that the drone survey turns out to be very effective in terms of diagnostics and degradation mapping of inaccessible structural elements. Figure 4 reports a selection of photos obtained with the drone survey.

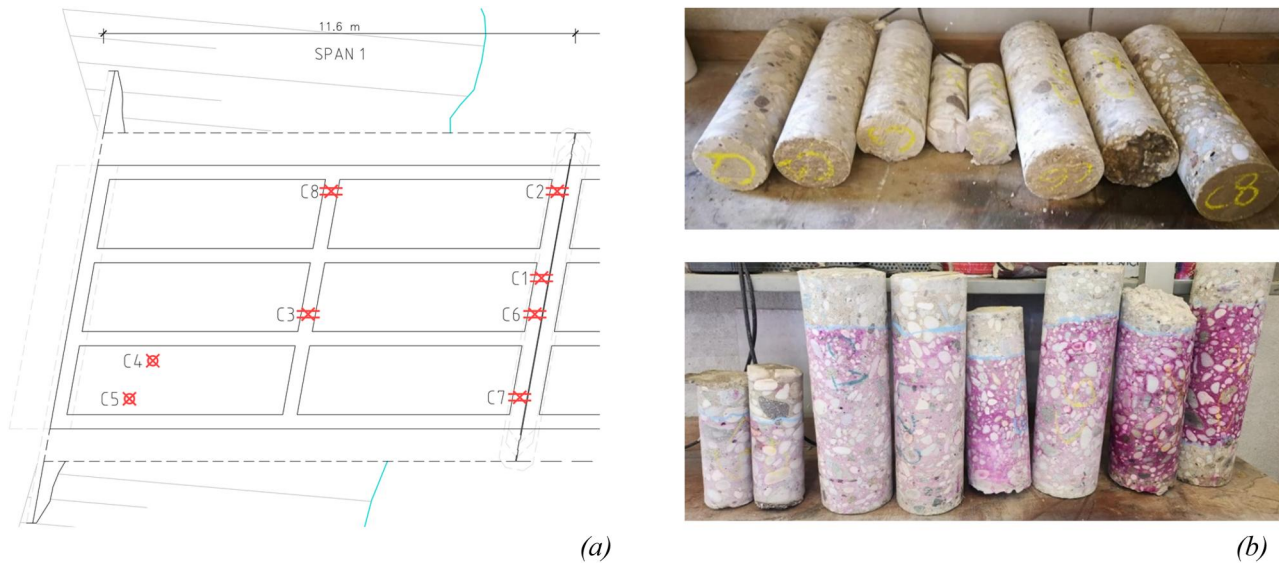
Figure 7. (a) Sampling points for concrete specimens along the bridge; (b) photos of the specimens.

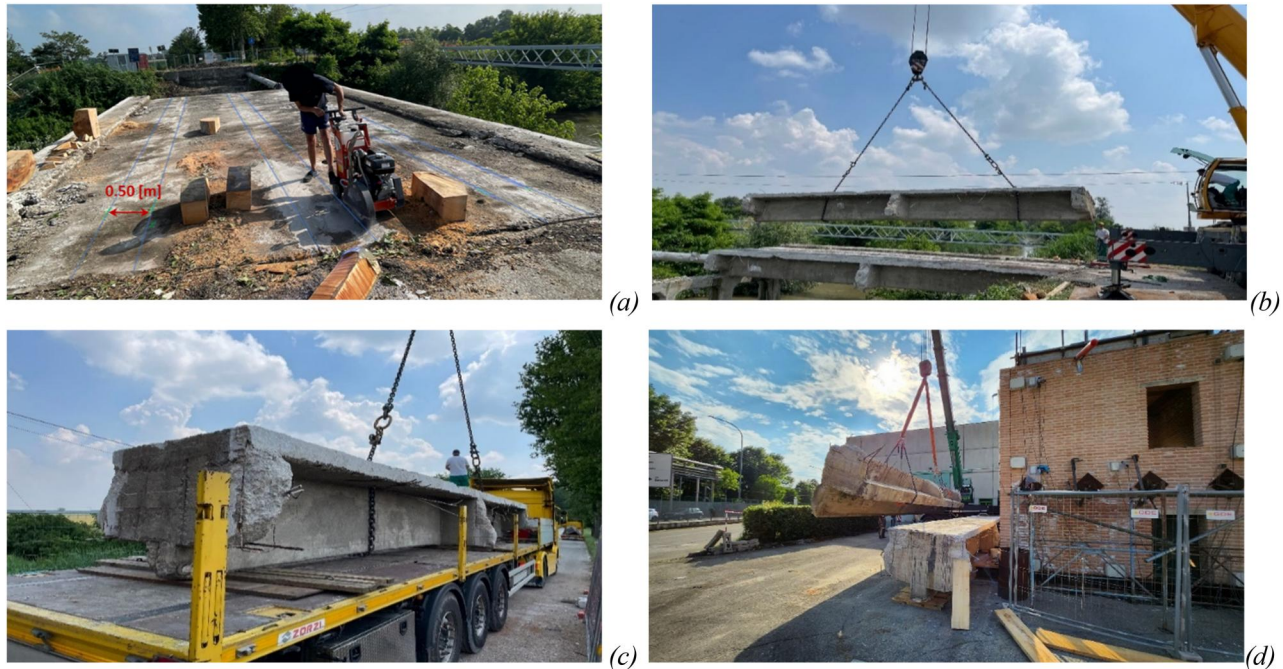
Figure 9. Main phases of the demolition process: (a) cutting of the slab and demolition of the transverse beams; (b) lifting of the girders; (c) loading the beams onto the truck bed; (d) positioning of the girders at the CIRI-EC structural testing laboratory of the University of Bologna.

order to extract suitable girders to conduct bending tests in the mechanical laboratory of CIRI-EC of University of Bologna. Four girders were extracted from the deck according to the deconstruction scheme represented in Figure 8. The deconstruction process involves: cutting, lifting, transportation and positioning phases, as reported in the photographic sequence of Figure 9.

girders were lifted using a high-capacity mobile crane (Figure 9b). The lifting points of the beams were defined in order to avoid tension forces on the slab, thus avoid its cracking. It is worth nothing that the lifting phase is critical as it stresses the girder with a different static scheme and load pattern compared to the on-site configuration. The relevant weight and dimension of the girders required exceptional transports by truck to move the girders from the bridge site to the laboratory (Figure 9c). Finally, the girders were stored at the structural laboratory of CIRI-EC of University of Bologna (Figure 9d).

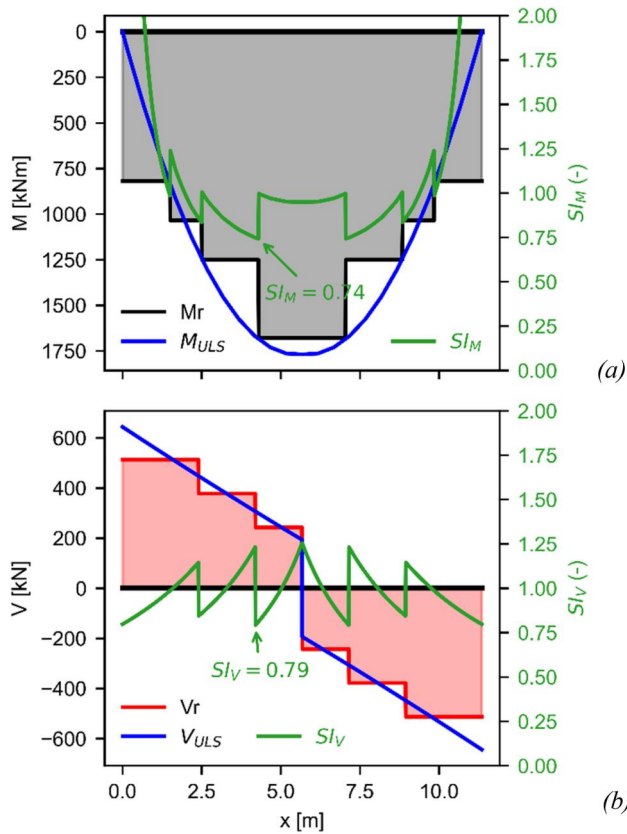
Figure 11. Distribution along the beam of resisting and acting: a) moment; b) shear. Acting moment and shear are computed with reference to provided traffic actions by Italian code (MIT, 2018) at ultimate Limit state. The green lines represent respectively the safety index for moment (S_M) and shear (S_V) computed as the ratio between capacity and demand. The minimum safety index is indicated by green arrow.

Code (MIT, 2018) at Ultimate Limit State. The same figure depict the safety index evaluated as the ratio between capacity and demand. As it can be seen the minimum safety index corresponds to a flexural failure in the central portion of the beam.

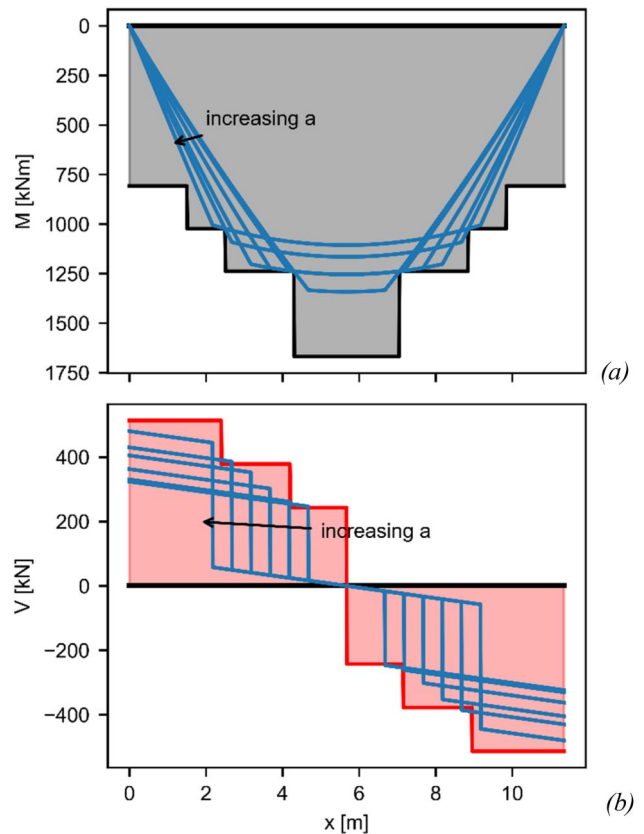
Figure 12. Distribution along the beam of resisting and acting: a) moment; b) shear. Acting moment and shear are evaluated as a function of the load leading to flexural failure for different distance a between the forces: 2, 3, 4, 5, 6 and 7 m.

On the other hand, with the aim of simulating the experimental setup, in Figure 12 the superimposed blue curves represent the internal forces for increasing distance a between the loads (i.e. 2 to 7 m, corresponding to a shear-span-to-depth ratio about between 4 to 2), and for load values equal to those leading the flexural failure (in some section of the beam). When the applied shear force is higher than the resisting shear, a shear failure is expected, while in the other cases a flexural failure is expected. It is possible to observe that a shear failure is expected for 2 and 6 meters of distance between the forces. This can be better evidenced looking at Figure 13a, where the ultimate loads for both flexural and shear failures are depicted as a function of distance between the loads.

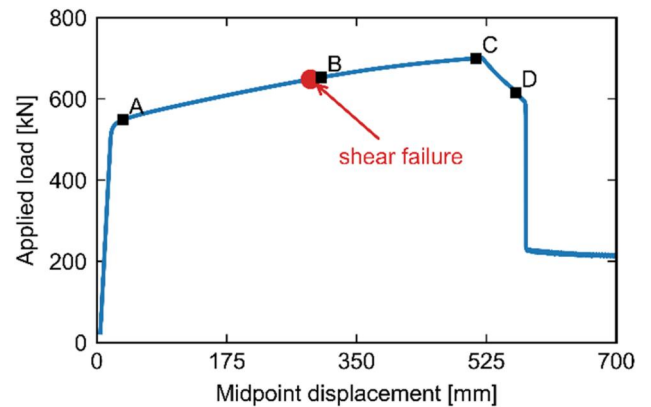
Figure 18. Force-displacement curve obtained by static non-linear analysis. Point A: yielding; point B: incipient failure of upper concrete cover; point C: peak load; point D: softening branch.

Since the adopted fiber-based modeling is not able to take into account shear failure, shear strength was estimated by the analytical truss model adopted also for the preliminary design phase. A post-processing check was then carried out at each load step, indicating with a flag when shear failure occurs, corresponding to the attainment of the yield strength for stirrups. The force-midpoint displacement curve obtained by static non-linear analysis is depicted in Figure 18, The red circle indicates the attainment of the shear failure: as expected from the results of the previous analysis, the shear failure takes place after yielding phase of the longitudinal bars, occurring at about 20 mm of midpoint displacement and about 530 kN of force. The peak force is about 700 kN for a corresponding midpoint displacement of about 520 mm.

After the peak, the force-displacement curve exhibits a softening branch due to the crushing of concrete in the flange. Figure 19 shows the compressive stresses in the upper zone of the beam in four different points of the force-displacement curve, respectively at longitudinal bar yielding (A), at the incipient failure of upper concrete cover (B), at the peak load (C) and in the softening branch (D). After the peak stress attainment, observing the compressive stresses in the fibers immediately adjacent to the point of force application, it can be seen that there is a sudden lowering of the neutral axis until reaching the upper edge of the web of the beam

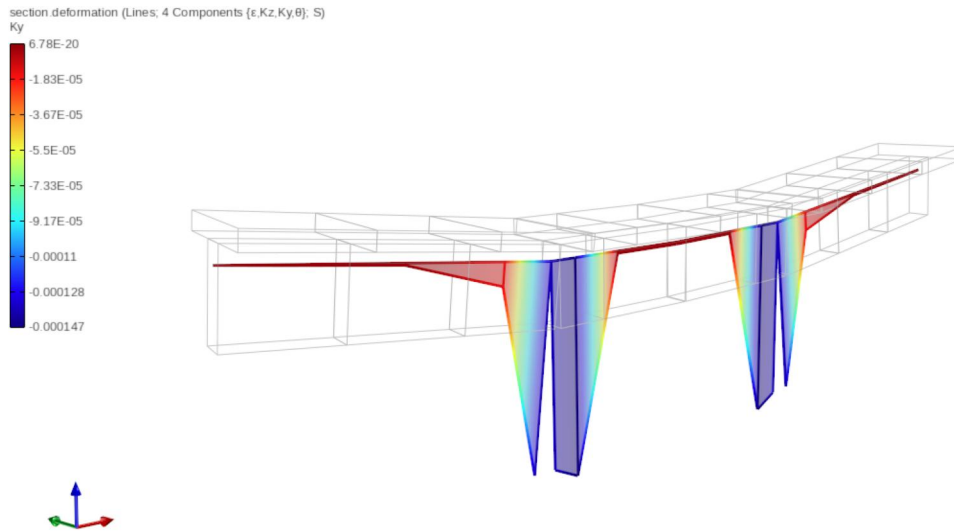
Figure 20. Curvature distribution (mm^{-1}) corresponding to a midpoint displacement of about 520 mm.

(compare the fibers in the zoomed zones in Figure 19c,d). After yielding, the curvature shows a localization in the two regions close to the force application, where the bending moment is almost maximum but the reinforcement area is smaller than that present in the central zone, see Figure 20.

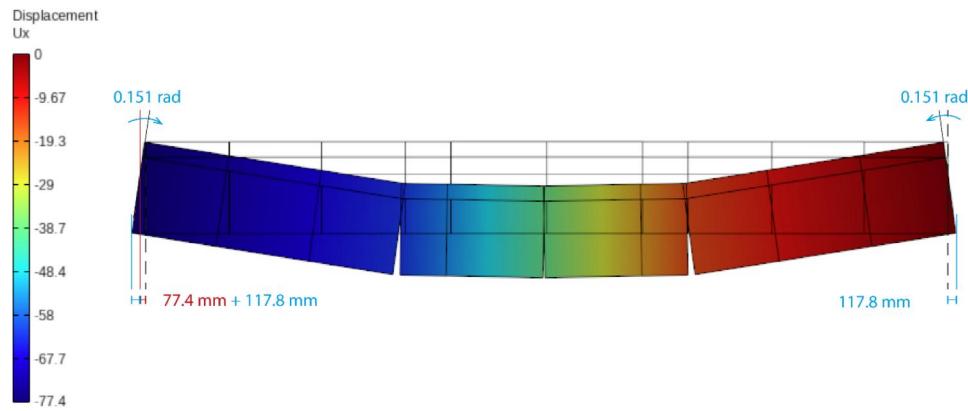
Figure 21. Contour of x-displacement of the beam element at the end of analysis and displacements at bottom side.
