# Non-destructive techniques for structural characterization of cultural heritage: A pilot case study

## Summary

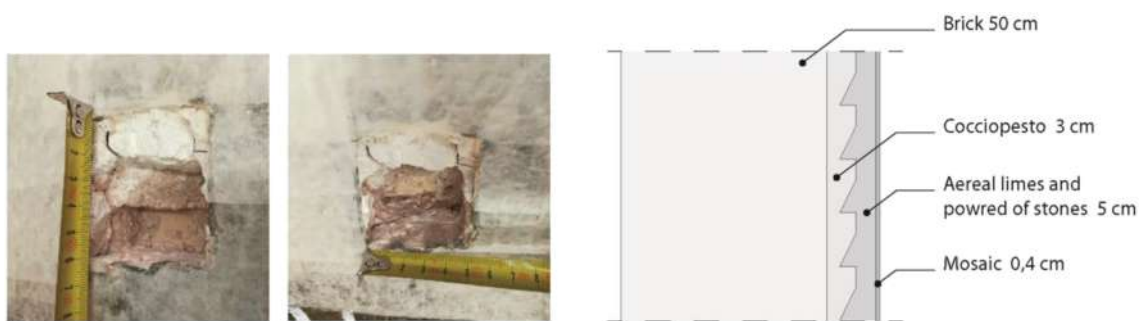
FIGURE 3 Masonry stratigraphy

A previously performed survey provided the stratigraphy of the walls supporting the vault. They are composed of, starting from the inside, a 0.4-cm mosaic, a 5-cm aerial lime and stone power layer, a 3-cm *cocciopesto* layer, and a 50-cm load-bearing masonry wall (Figure 3).

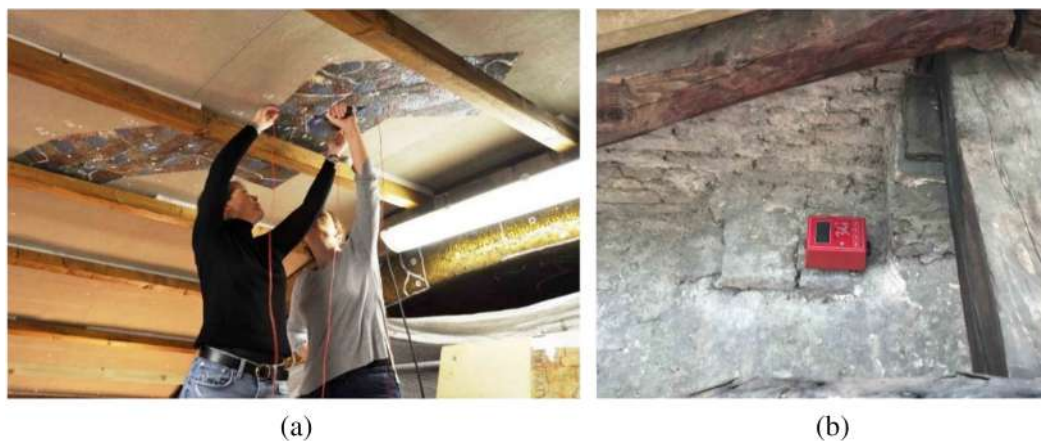
FIGURE 5 In situ measurements using (a) sonic testing and (b) tromograph device

Two kinds of measurements have been conducted: sonic tests (Figure 5a) and microtremors measurements (Figure 5b). The sonic investigation technique is based on the principle that the propagation velocity of elastic waves in a solid is related to the material mechanical and physical characteristics. This technique is based on elastic waves in the sound frequency range (20 Hz–20 kHz), generated by a mechanical impulse applied to the structure. In particular, the propagation velocity of a wave moving through an elastic, homogeneous, and isotropic solid is a function of the dynamic elastic modulus, the Poisson coefficient, and the solid density.

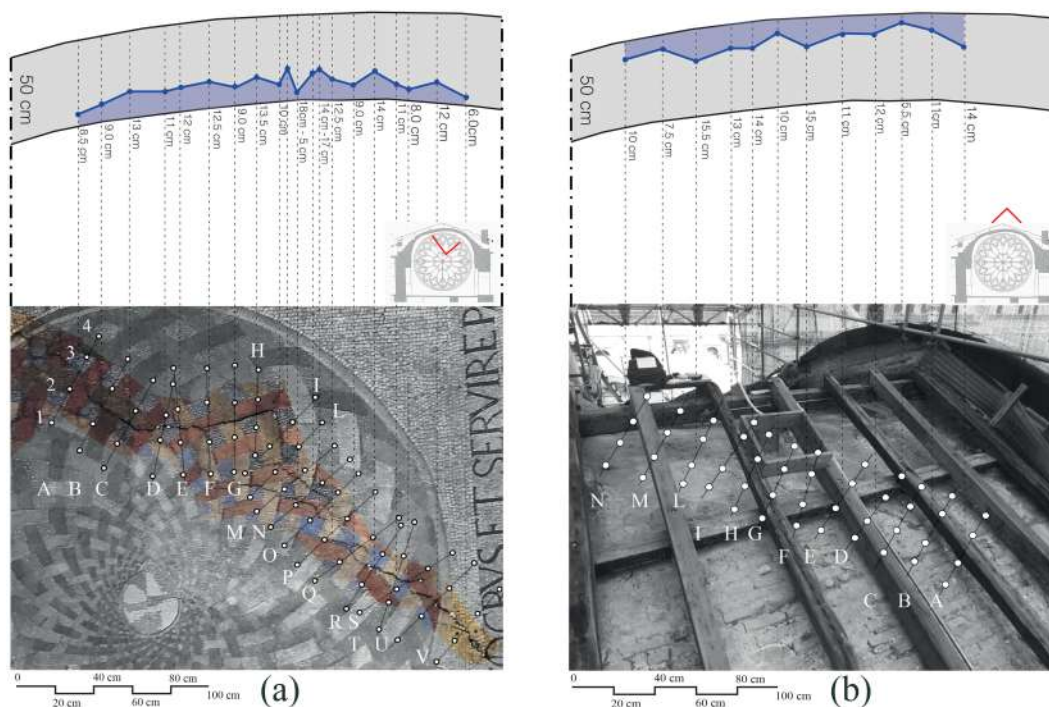
FIGURE 6 Damage survey and experimental measurement of crack depth: (a) Crack at the vault intrados; (b) crack at the vault extrados

The experimental measure of a superficial crack depth is often difficult and can be affected by uncertainties, since cracks are usually not perfectly orthogonal to the surfaces where measures are taken. In order to overcome this problem, a sufficiently large data population has been obtained by selecting 80 measurement points to perform the test, as shown in (Figure 6a). The distance between the measurement points identified with capital letters is about 20 cm, while the distance of those identified by the numbers 1 to 4 is 16 cm (Figure 6a). The test was repeated twice, adopting two configurations. In the first one, the hammer hit the position 2, while the accelerometers were placed at positions 1 and 3. In the second configuration, the hammer hit the position 3, and the accelerometers were placed at positions 2 and 4. The experimental measurements revealed a depth of the intrados crack between 6 and 18 cm with an average depth of 12.5 cm. Among the measurements made, it was chosen to exclude the L measurements because they have values discordant with the average of the data, possibly due to the crack bifurcation, which could have influenced the propagation time measurement.

The same experimental technique for estimating the crack depth has also been applied to the crack present on the extrados of the vault. However, due to site-related difficulties in positioning sensors on the extrados, the number of measurement points has been reduced. For the extrados, 48 measurement points were chosen (Figure 6b). Recorded data revealed a depth of the extrados crack between 7 and 15 cm with an average depth of 10.5 cm.

The performed tests showed that the cracks are partially overlapped. Along the overlapping zone, 1/3 of the vault thickness is affected by the damage and consequent loss of stiffness of the structure is expected.

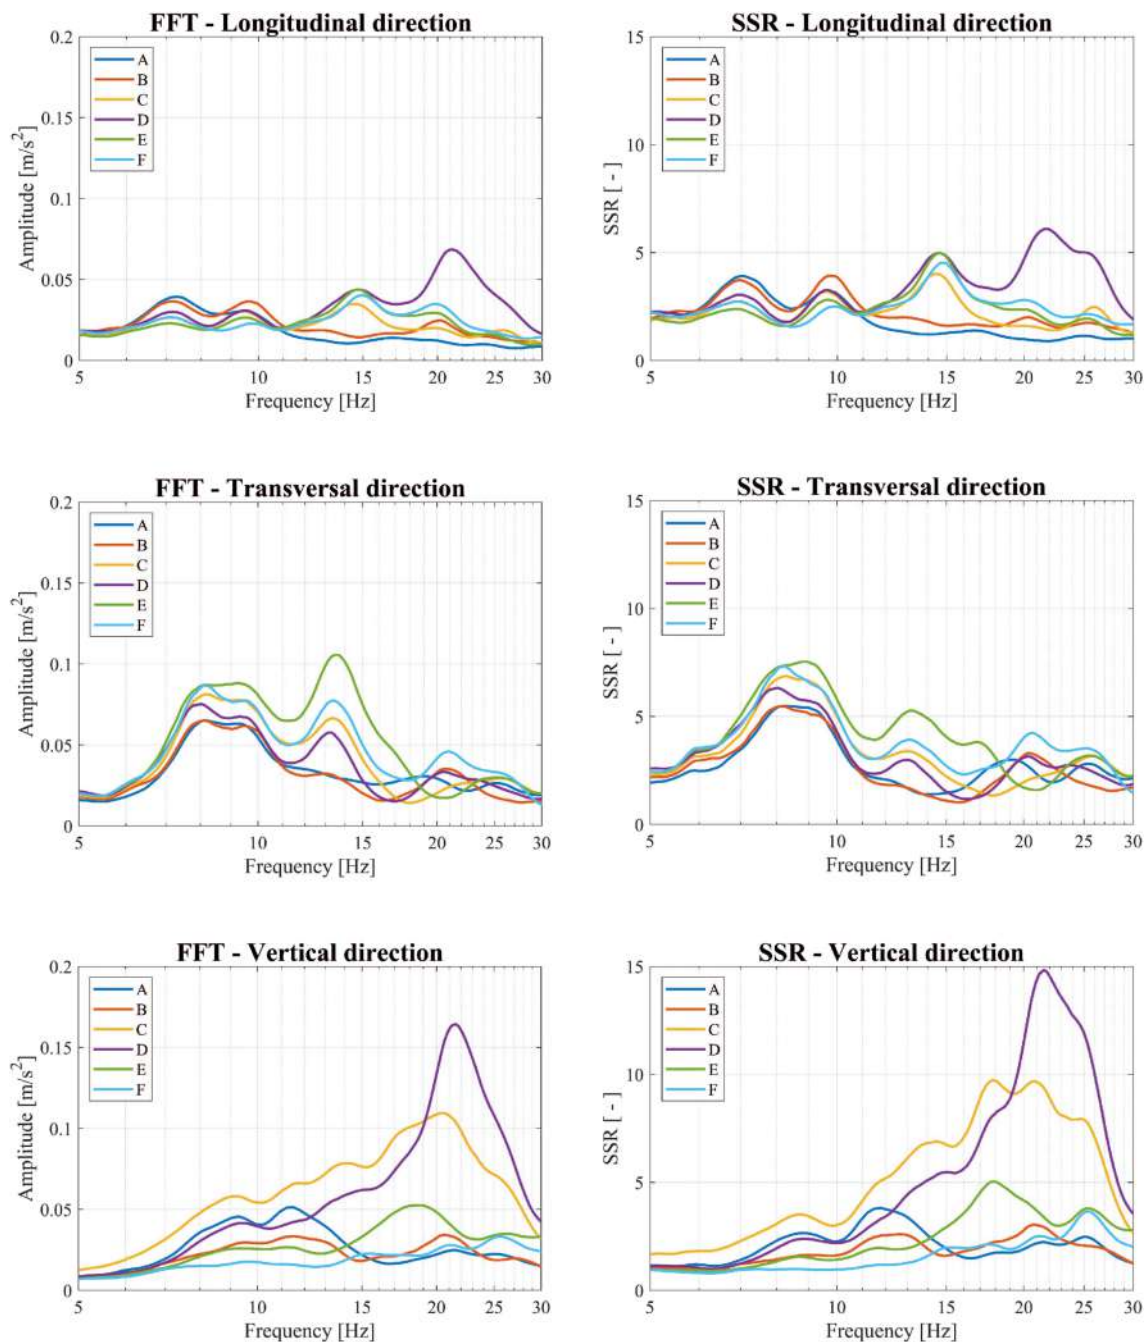
**FIGURE 10** FFTs and SSRs of acceleration signals recorded on the vault. SSRs were evaluated using the spectra of signals measured at matroneum as reference

signals recorded on the vault are presented, for components related to longitudinal, transversal and vertical directions, where the transversal direction is orthogonal to the rose window.

In Figure 10, SSRs of the acceleration signals recorded at the vault are also presented. Although spectra are not characterized by well-defined and isolated peaks, particularly high amplitudes are identified at specific frequency ranges, especially for the transverse and vertical components. In all signals, the transverse component is accentuated in a frequency range between 8 and 10 Hz, with a lower amplitude peak present in the range 12–14 Hz. Peaks also related to the longitudinal component can be observed in the latter range, while high-amplitude peaks for the vertical component can be observed in the range 20–22 Hz.
