Edificios de piedra australianos: naturaleza, degradación y conservación

Australian stone buildings: nature, degradation and conservation

Francesco Trovò
IUAV Universidad de Venecia

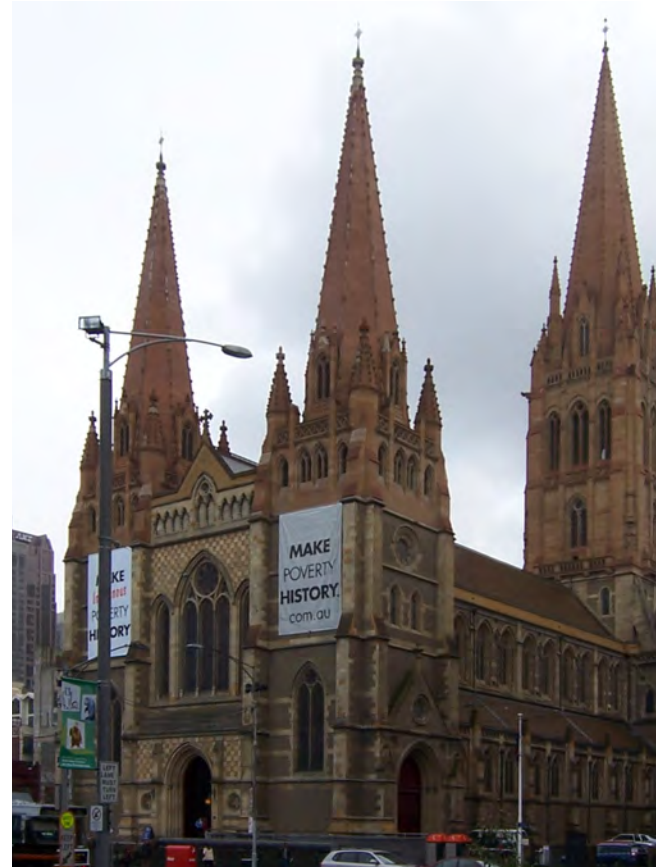
1

1. Catedral de San Pablo, Melbourne, 1880-81, arenisca Waurn Ponds y Barrabool

1. St. Paul Cathedral, Melbourne, 1880-81, Waurn Ponds and Barrabool sandstones

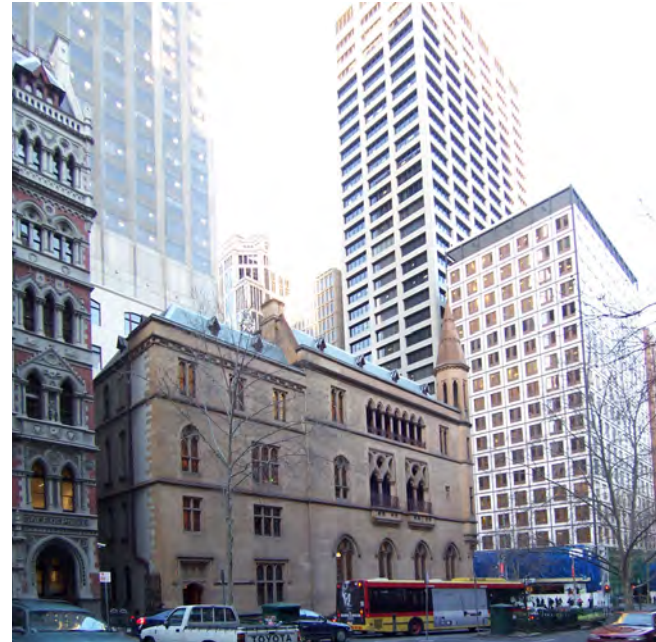
2

2. Gothic Bank, Melbourne, 1882-1887, arenisca Pyrmont

2. Gothic bank, Melbourne, 1882-1887, Pyrmont sandstone

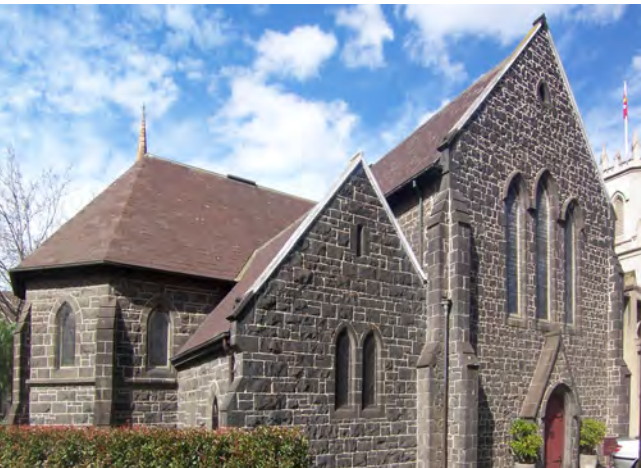
5

5. St Peter's Eastern Hill Anglican Church, Melbourne, basalto

5. St Peter's Eastern Hill Anglican Church, Melbourne, bluestone

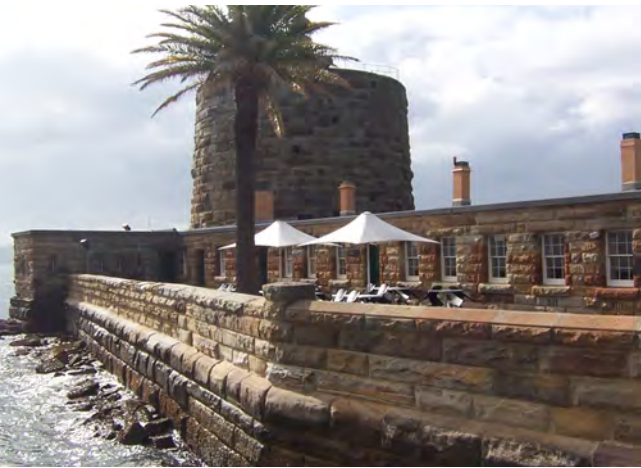
6

6. Fort Denison, Sydney. Vista general de la estructura defensiva, con la torre circular al fondo (la visita se ha podido realizar gracias al Government Architect's Office - NSW Department of Commerce - Sydney)

The case of Fort Denison, named after the former governor of New South Wales and completed in 1867, is particularly important, given its location and the heterogeneous nature and intensity of the degradation phenomena observed. Located in the centre of Sydney bay, in the Port Jackson inlet, it occupies all of the small island of Pinchgut. The structure of the building is typologically similar to that of the *Torri Martello*, and is the sole example of this in Australia. The *Torri Martello* were inspired by the circular fortresses of the Genoese defensive system, in *Torre della Mortella*, and have been found in Corsica since the 15th century. During the second half of the 19th century the British government built approximately 140 towers similar to this one, guarding the British coastline and the strategic points of British colonies worldwide.

The construction of the structure required the use of very heterogeneous types of stone, which have now been shown not to be of the highest quality, with the exception of the lower sections, as the materials used were mostly ashlar lime and sandstone, although the latter is particularly sensitive to the effects of material degradation.

Contact with sea water has triggered the early stages of the degradation of the material forming efflorescence due to salt crystallisation, with progressive erosion and detachment of superficial layers –especially in the case of sandstone – on the lower part of the walls. The initial restoration

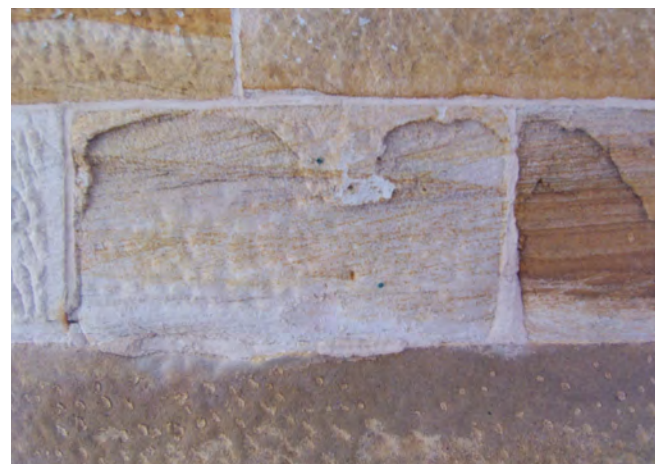
7
8

8. Fort Denison, detail of the masonry, and in particular the mortar joint, affected by the presence of salts. The heterogeneity of the stone ashlar can be clearly observed

interventions involved replacing the most damaged elements, filling the joints with mortar of a similar colour and material, and extracting salts using wraps on the better conserved parts (figs. 7, 8, 9).

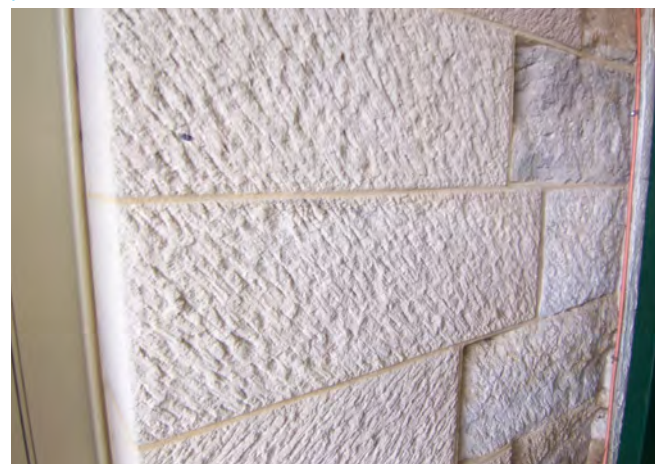
9. Fort Denison, part of the masonry replaced with related lithotype

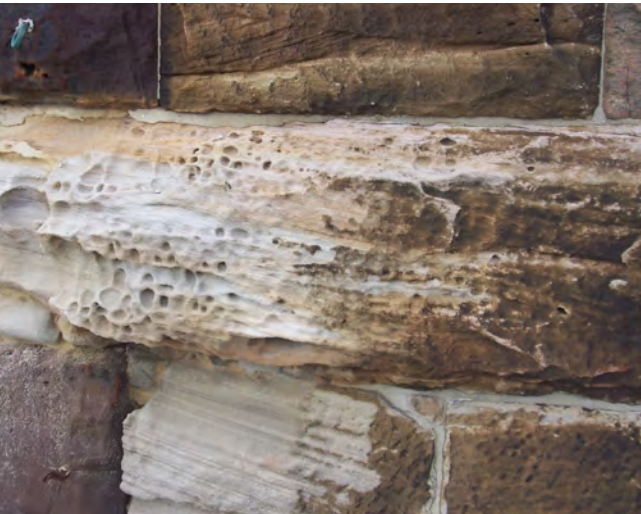
10

10. Fort Denison, part of the outer masonry affected by degradation due to wind action

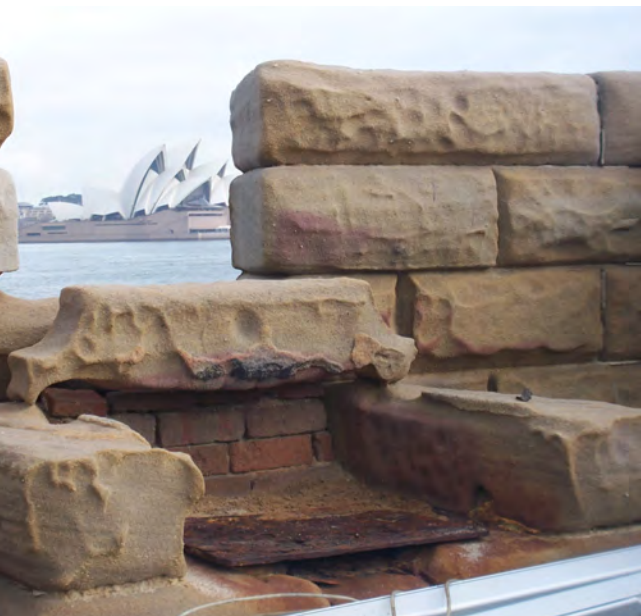
11

12. Fort Denison, black deposits and crusts can be observed on the less exposed surfaces

The interest of the case study also lies in the fact that a wide range of degradation phenomena can be observed in a single building. On the surface areas exposed to atmospheric agents, wind in particular, large areas of stone displaying erosion can be observed, while others are affected by alveolarization, and in some cases also pulverisation (figs. 10, 11). Equally, deposits and black crust appear on the less exposed surfaces, and in the long term cause considerable loss of matter due to the sulphation of the substratum of the stone.

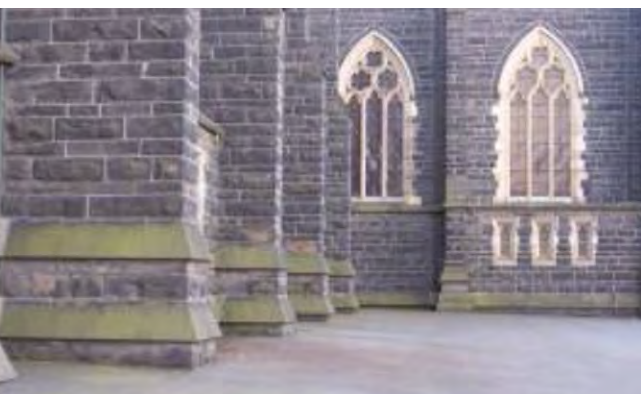
16

16. St. Patrick's Roman Catholic Cathedral, Melbourne, basalto. Pátina biológica

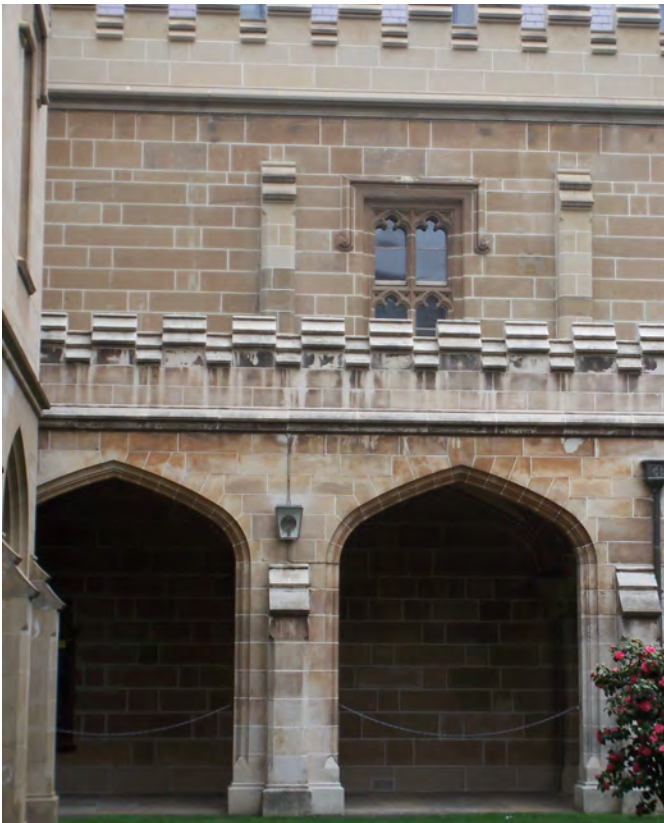
20

20. Old Arts Building at the University of Melbourne, limestone and sandstone. The crowning has undergone complete replacement

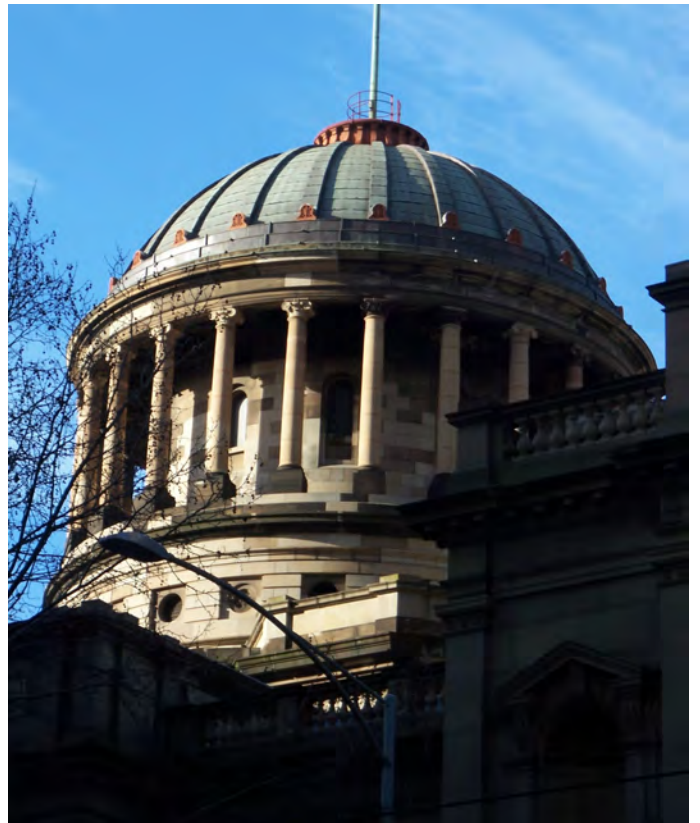
21

21. Supreme Court, 1874-84, Melbourne, Tasmanian freestone and bluestone. The masonry inside the colonnade of the dome has many stone replacements

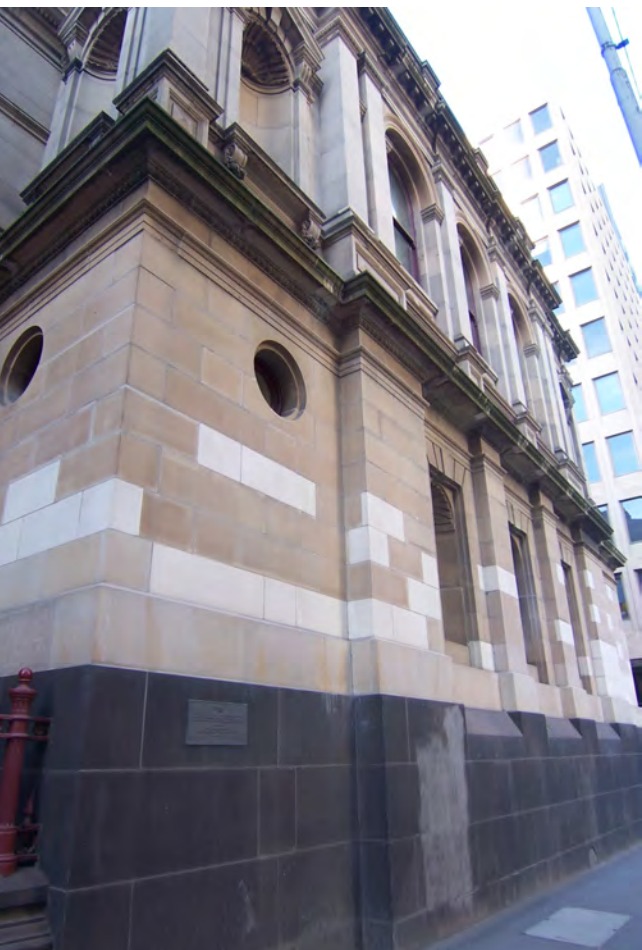
22

22. Tribunal Supremo. Se pueden observar varias sustituciones de sillares de piedra

22. Supreme Court. Observe the numerous replacements of stone ashlar on the masonry

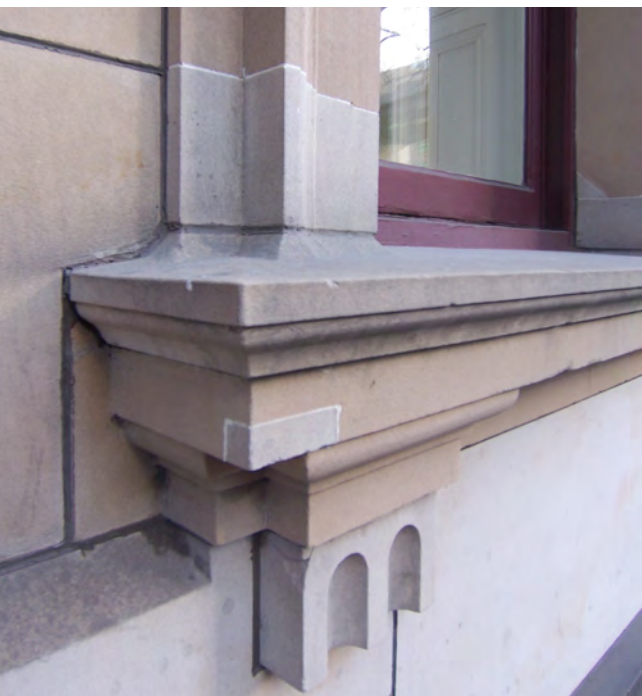
25

25. Tribunal Supremo. Se observan muchos injertos realizados para evitar sustituir los elementos atendiendo al criterio de mínima intervención

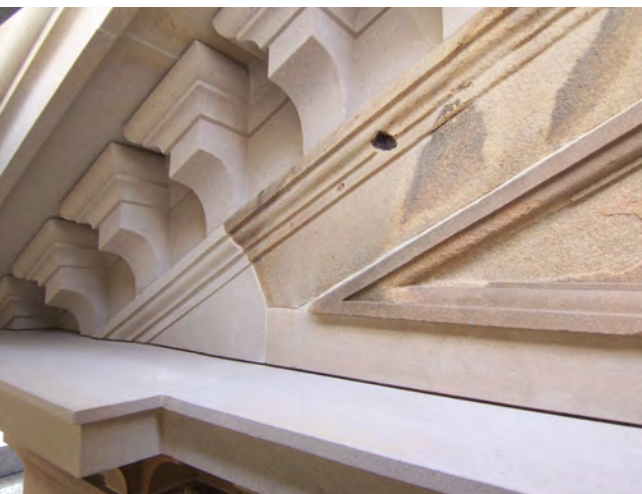
26

26. Royal Prince Albert Hospital, Sydney, sandstone. Here there is extensive replacement of elements, done in a very heartfelt way. In this context the new parts are predominant (the visit was made possible thanks to the Government Architect's Office - NSW Department of Commerce - Sydney)

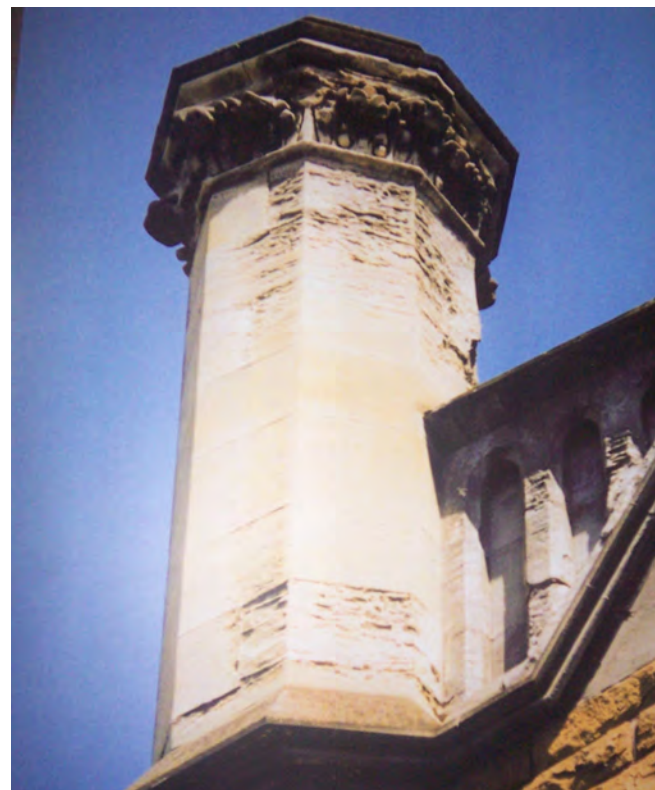
28

28. St. Mary's Star of the Sea, 1854-1900, 2003-today restoration, Melbourne. Obsérvese la base de la aguja perdida, realizada en arenisca (cortesía de Falkinger-Andronas, Melbourne)

28. St. Mary's Star of the Sea, 1854-1900, 2003-today restoration, Melbourne. The base of the lost spire can be seen; the new elements equal to the previous ones were both made of sandstone (courtesy of Falkinger-Andronas, Melbourne)

Specific replacement interventions have been observed in the reconstruction of the spires of two major churches in Melbourne, St. Mary's Star of the Sea and St. Paul's Cathedral. These elements, which rise from the roof, show a high propensity to disintegration, causing stone elements to break off and detach. In both cases, the spires were faithfully reproduced in a laboratory by a monumental mason and reassembled in their original position.

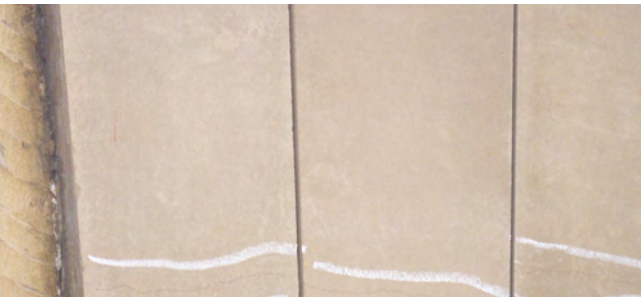
37

37. Newman College. Las retracciones durante la fase de secado del producto han provocado la formación de microlesiones, que han sido rellenadas y estucadas sucesivamente

37. Newman College, shrinkage phenomena during the drying phase of the product resulted in the formation of micro-lesions, which were later repaired and grouted

adherence – and in turn durability – of the mortar. This is a particularly delicate operation as even the slightest tension caused by these pieces could lead to the appearance of microscopic lesions and cracking, compromising the quality of the intervention, as in the case of Newman College
