A Multidisciplinary Approach for the Vulnerability Assessment of a Venetian Historic Palace: High Water Phenomena and Climate Change Effects

The proposed multidisciplinary method is applied to the case study of Palazzo Malipiero, located in Campo San Samuele in Venice, focusing on theoretical and operational issues.

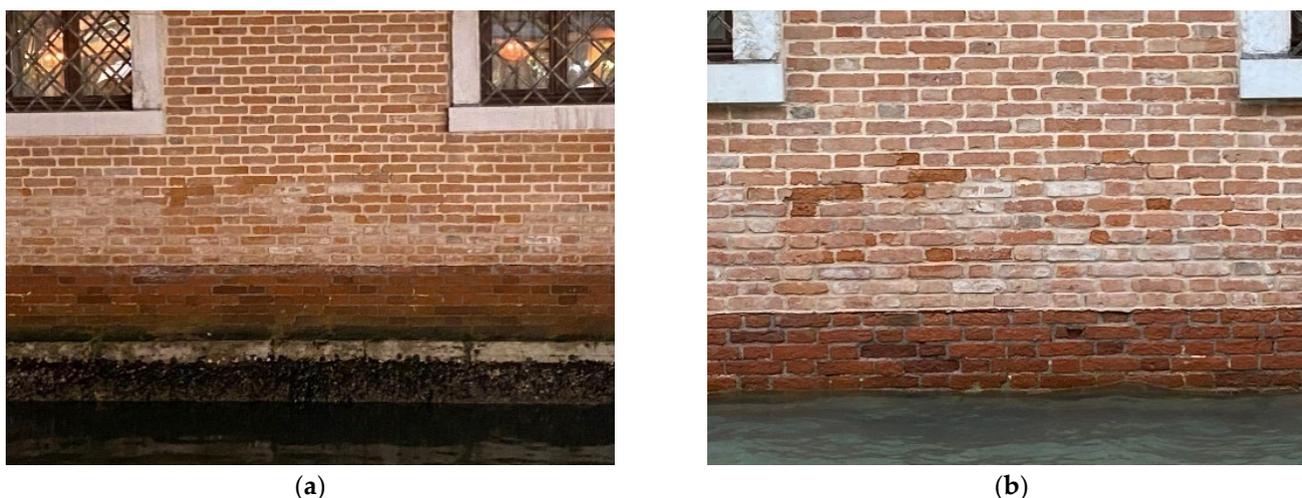
Figure 5. Venice: Example of building with no more effective “*cadene*”: (a) low tide; (b) high tide.

The contribution of the Historical Analysis (HA) is performed in the research of natural or anthropic transformations that have affected the historic building and which may have increased the structure's vulnerability. The analysis of historical data obtained, for example, from cadastral maps, is an indispensable preliminary phase able to guide the planning activity of direct surveys on the artifact. Of crucial importance is the knowledge of Venetian manufacturing features referring, for example, to high tide protection historical tools, which allow, among other things, to conduct correlations between the current state and the past in terms of zero tidal sea level variation. A typical example of a protection tool is represented by the installation of the so-called "*cadene*", continuous courses of Istrian stone blocks, a low porosity material and very resistant to salt corrosion, Figure 4. These elements, at the time of construction, were collocated at a regular height interval in order to create a waterproof layer up to a certain level above the mean sea level, but to date, it can be largely exceeded from daily tidal excursions [39–41]. Figure 5 shows an example where the lack of efficacy in the "*cadene*" is underlined by the presence of corrective measures, such as the mechanical cutting of the masonry and indenting of damaged bricks (i.e., the so-called "*cuci-scuci*" technique). In particular, Figure 5a depicts the presence of green-brownish patina of algal vegetation, indicating the level reached by the water during the daily tidal variations, witnessing the lack of efficacy of "*cadene*" on a high tide, as shown in Figure 5b.
