Maintenance of all FRP pultruded structures. A Case study.

Ileana Ippolito¹ and Salvatore Russo²
Iuav University of Venice, Italy ¹iippolito@iuav.it ²russo@iuav.it

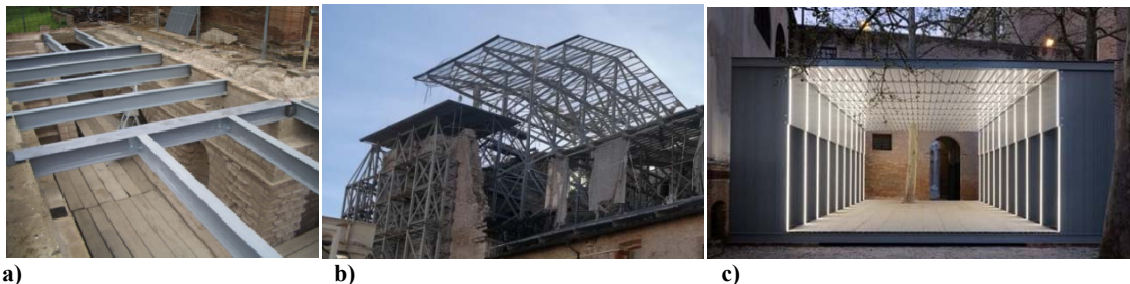
Figure 1 Examples of FRP structures, a) temporary walkway, b) post-earthquake coverage, c) Glass-House.

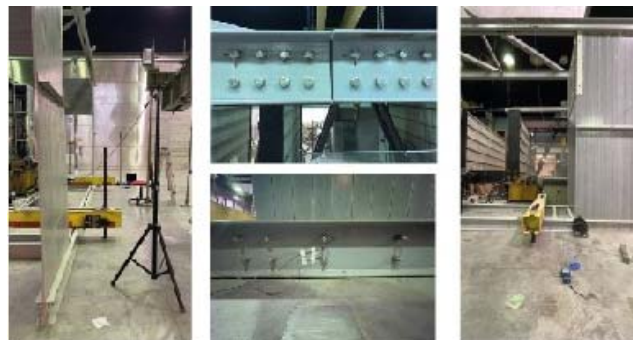
- *Global monitoring*, actuator data reprocessing. The characteristics of the linear hydraulic actuator used is Model 201.35T with maximum capacity in compression: 365kN, maximum capacity in tension: 250Kn (Figures 6);
- *Local monitoring*, with the application of 3 transducers and a rotational control system [TR1-TR2-TR3]connected to an external data-return unit (Figures 7);
- *Spot monitoring*, carried out by the acoustic emission technique for dry latch testing using a controlled-tightening torque wrench, a 16-bit A/D converter on each channel to which a 19-mm-diameter stainless steel AE sensor with an operating frequency of 35-100 kHz, a peak sensitivity of 75 dB (Ref V/m/s) and a resonant frequency of 50 kHz was connected. The standards used to perform the tests were ISO 1996: 2-2017, DIN 45681:2005-03 and BS 4142: 2014. (Figure 8) (Ippolito and Russo, 2022).

Figure 6 Monitoring system used in testing.

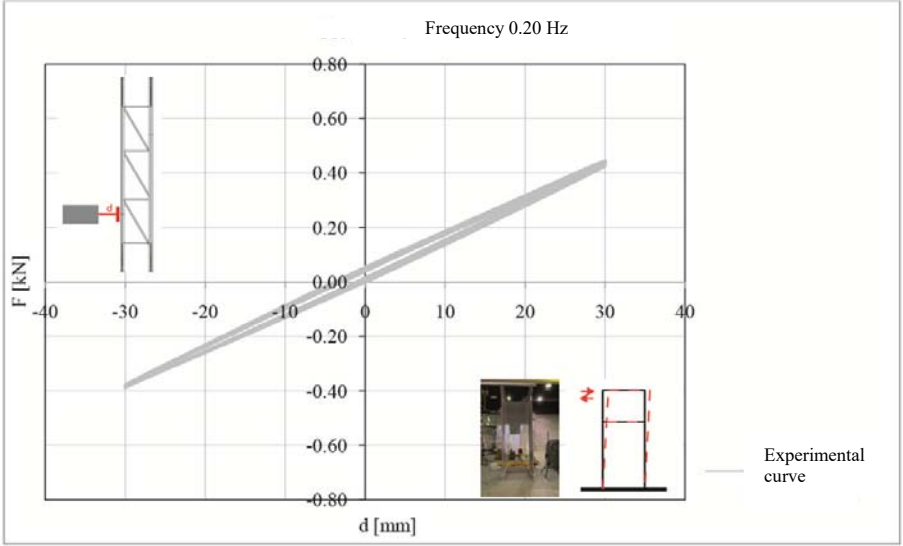
Test III: The graph below is the result of Test III (Table 1), lasting 4 days, during which the structure was stressed with a frequency of 0.20 Hz. The displacement throughout the duration of the test was controlled by the control unit system connected to the actuator and was imposed at 30 mm.

Figure 13 Load-Displacement Chart 0.20 Hz

The results represent the hysteresis cycles achieved by the structure over the 96-hour test period. The bond undergoes a translation of ϵ_p , reducing by 2% (Figure 13).

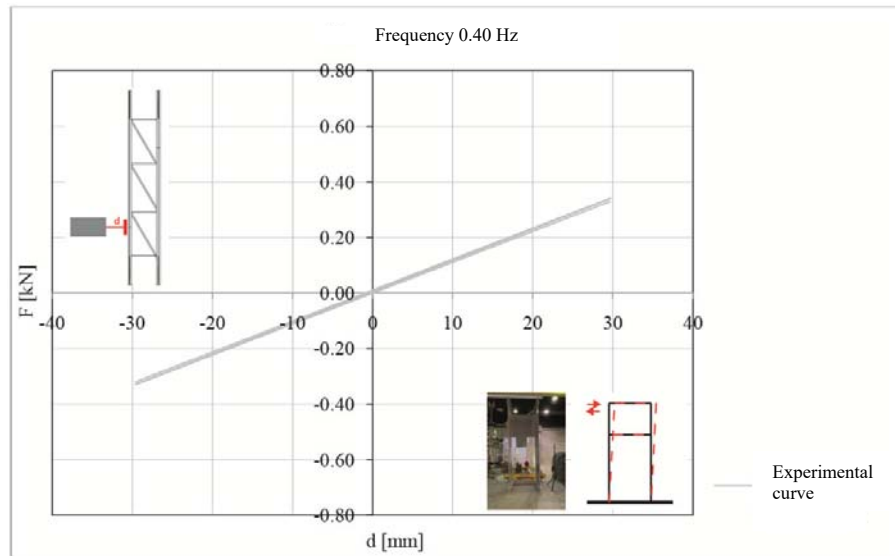
Test VI: The graph below is the result of the VI Test (Table 1), lasting 3 days, during which the structure was stressed with a frequency of 0.40 Hz. The displacement throughout the duration of the test was controlled by the control unit system connected to the actuator and was imposed at 30 mm.

Figure 14 Load-Displacement Chart 0.40 Hz

The results represent the hysteresis cycles achieved by the structure over the 72-hour test period. Unlike the tests with lower frequencies, it can be seen from the graph (Figure 14) that the structure has a hysteresis cycle that tends to zero. During this phenomenon, the tension-strain cycle tends to overlap and remain stable. This phenomenon along with the phenomenon of accommodation are effects of the deformation cycles in the plastic field.
