SURVEY, DIAGNOSTICS, MONITORING METHODOLOGY AND DIGITAL TWIN FOR THE CONSERVATION OF THE FACADE OF THE CHURCH OF SANTA MARIA DI NAZARETH IN VENICE

I. Rocca^{1*}, I. Forti¹, G. D'Acunto¹, A. Saetta¹

1.1 The façade of S. Maria di Nazareth church of Carmelitani Scalzi order in Venice: diagnostics for restoration project

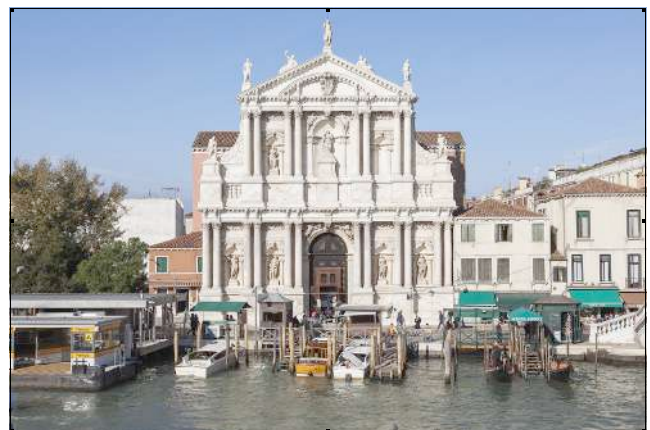
Figure 1. Facade of the church of Santa Maria di Nazareth, at the end of the restoration works in December 2018.

The baroque façade of the church of Santa Maria di Nazareth (*vulgo* degli Scalzi), a work of the late seventeenth century by Giuseppe Sardi, besides being a monument connoting the city of Venice, located at the entrance to the lagoon city, is a unicum in the context of the city, as it is entirely made of Carrara marble (Bettini and Frank, 2014), a lithotype rarely used in the Venetian environment. Over the centuries, this saccharide-based limestone has proved unsuitable, in particular given its location on the outside which subjects it to the aggressiveness of the lagoon climate, in addition to the sudden rise and fall in temperature due to both radiation and frost, Figure 1.

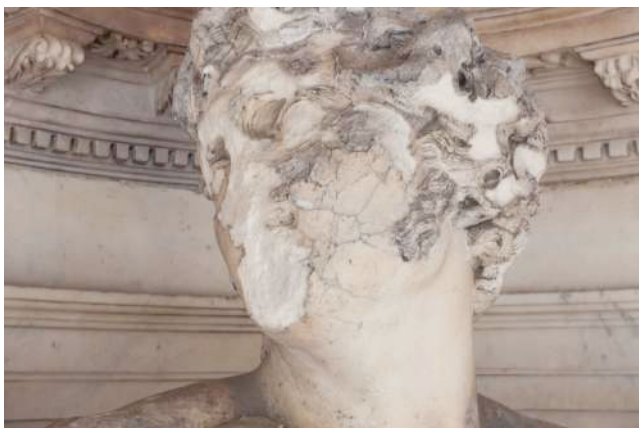
Figure 2. Detail of the degradation, 2016. -- Detail of the head of San Giovanni Battista: the Carrara marble shows different states of decay, the main ones being erosion, pulverization, widespread craquelure and chromatic alteration.

In many parts, especially in the more projecting ones, the stone surface came to detachment and pulverization by simple contact, Figure 2-3.

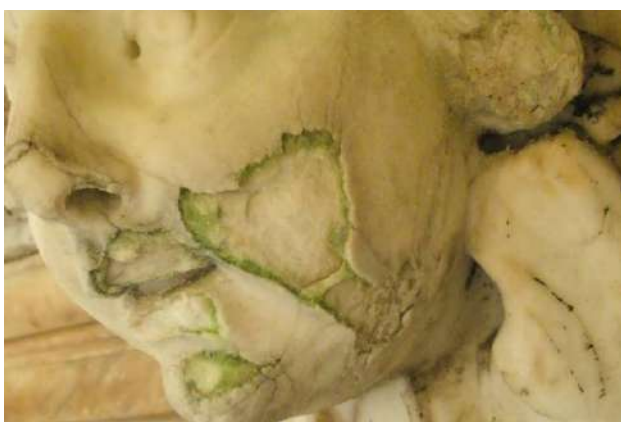
Figure 3. Detail of a cherub placed in the string course of the second order of the façade, clear example of different states of degradation of Carrara marble.

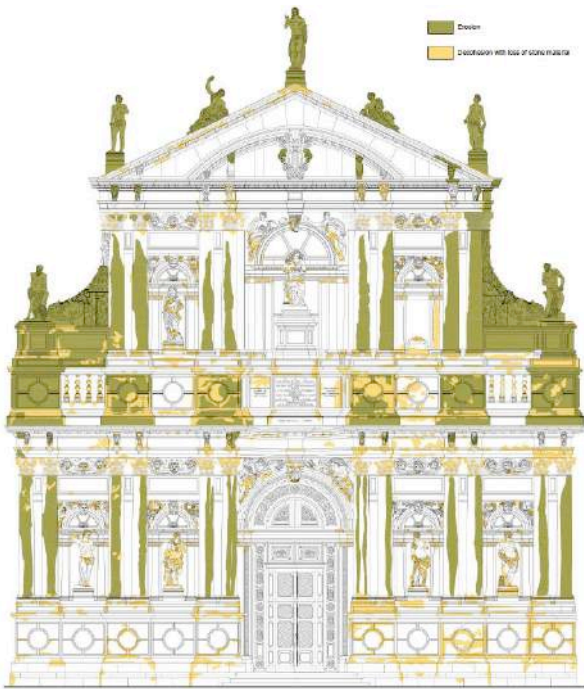
Figure 4. Mapping of degradation phenomena: erosion and decohesion

As described, the surface condensation processes of humidity and mists have proved particularly harmful for Santa Maria di Nazareth façade. Since such a dramatic condition/precarious state of conservation of the Carrara marble (made explicit via the map tool, Figure 4) did not find match in existing scientific literature, an experimental research in collaboration with the CNR/Institute of Geosciences and Earth Resources of Florence was undertaken. Thus, a fundamental partnership for choosing the consolidation agents and the method of application as well as for validating the performance was established (Forti et al., 2021).

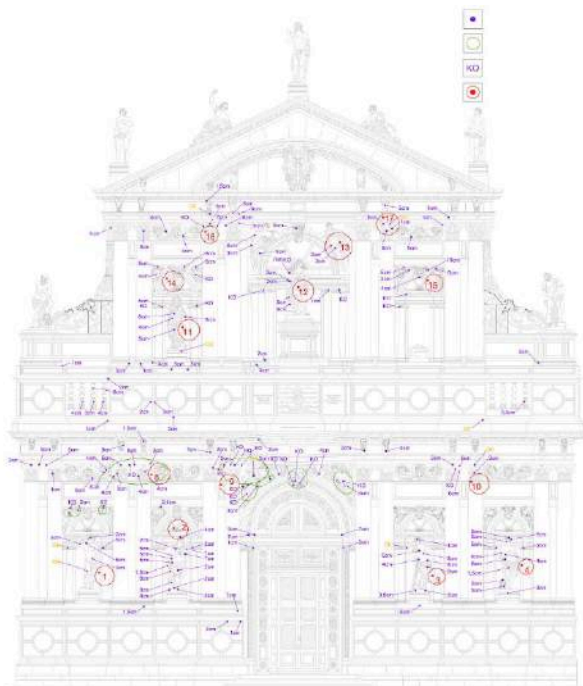
Figure 5. Mapping of tests drilling

At the end of this consolidation phase, micro-cores were performed with recovery and analysis of the powders in the most degraded areas, to verify the actual quantity of product applied and above all the depth reached by it. They are detectable through a map, Figure 5.

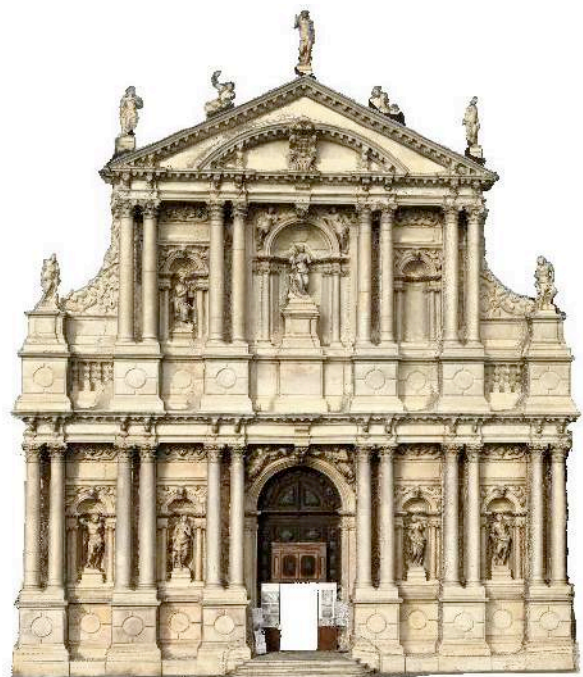
Figure 6. 3D digital model of the façade

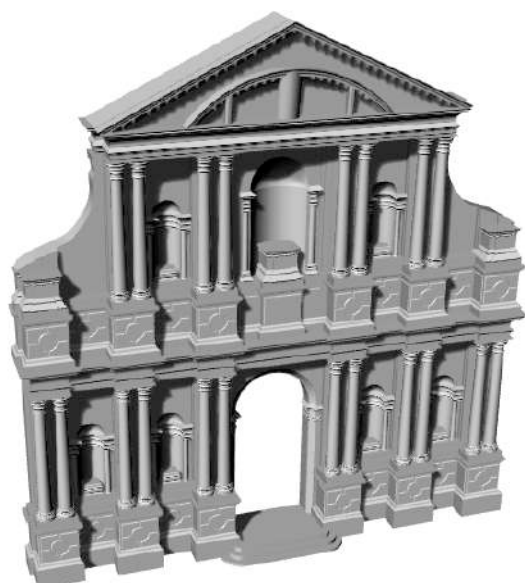
Figure 7. Digital Twin of the façade: 3D digital model representative also of the correct volumes

From the automatically oriented images a dense points cloud was obtained, which was scaled and roto-translated into the reference system, allowing integration with laser scan data. The following process of polygonal modeling occurs through creation parameters that follow a three-dimensional coordinate system and the obtained polygonal objects (meshes) return reality both as shape and as texture.

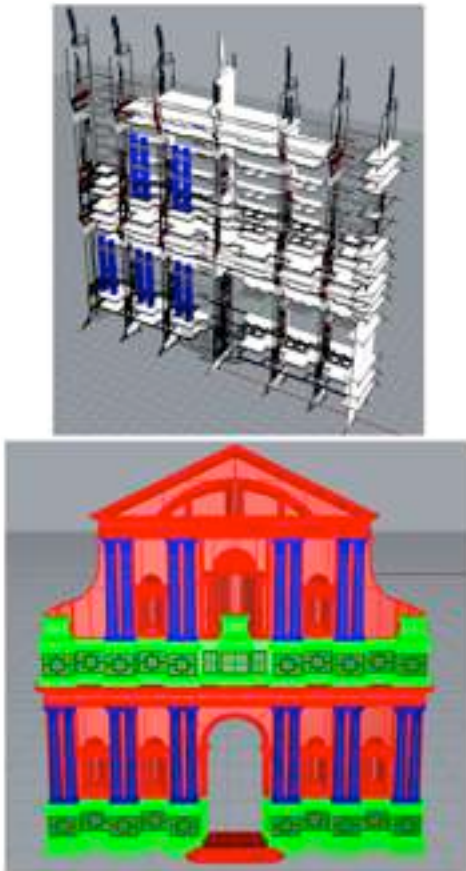
Figure 9. 3D model for static and seismic evaluations

Through the software for the creation of three-dimensional models and the process presented earlier, a 3D digital model of closed and controlled shape is obtained, for the control of the actual state and the predisposition of safety assessments, alias for the element preservation, both against the action of time and against any risks from external actions such as wind or earthquake.

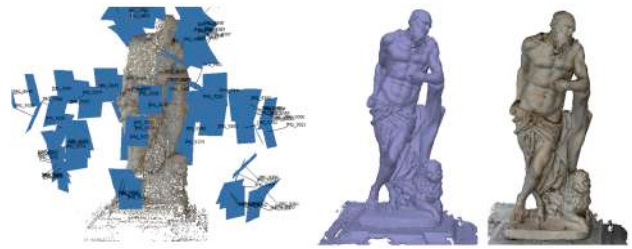
Figure 10. Step of 3D modeling of the statue of San Girolamo of the façade

On this model the FEM 3D mesh model was then built, in which, in a digital environment it was also possible to experiment and verify several hypotheses of restoration and structural-static consolidation. A punctual example is the analysis of the statue of San Girolamo (Figure 10) with the presence or not of metal retaining rods, intervention designed in the last restoration. These small metal structures are made of stainless steel and support the statue from the back, without being directly amortized in the marble. The above model, set up thanks to the innovative data acquisition methodology, provides a controlled representation of the geometric shape (Marra et al., 2021), which makes it possible to assess the statue stability when it is subject to the force of wind or earthquake, with and without metal retaining rods, thus verifying the effectiveness of the intervention. In other cases, as for the statues of San Sebastiano, San Giovanni and Santa Maddalena, the corresponding 3D digital models allow both to identify the most critical areas, namely where cracks for tensional concentrations are detected, and to carry out advanced FEM analyses to confirm the presence of such concentrations and to evaluate the adequacy of the installation of stainless steel bars in the statues as stitching of the deep cracks found before restoration.

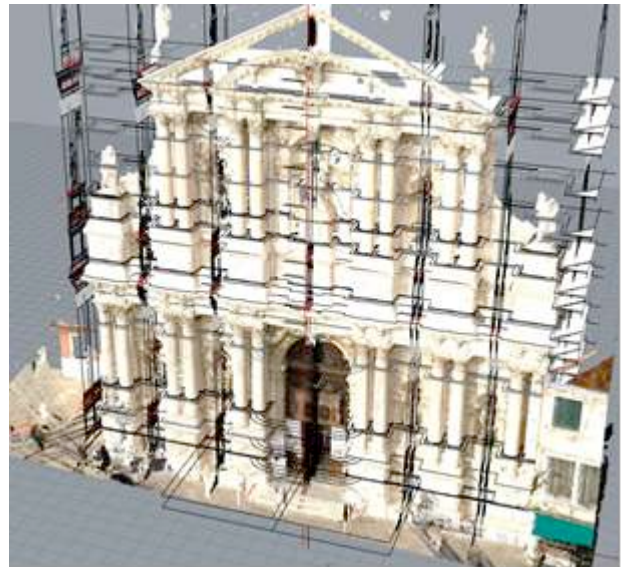
Figure 11. Overlay of section planes on the 3D model

The monitoring of the structure through a procedure indirect, non-invasive and that uses digital technologies is therefore an activity of fundamental importance in the context of monumental assets such as the façade of the church of S. Maria di Nazareth in Venice. Through this it is possible to obtain information on the state of the "façade system" and on the possible evolution of the criticalities found, Figure 11.
