Modal Analysis for Study of Minor Historical Architecture

Milorad Pavlovic, Anna Manzato, Antonella Cecchi

Keywords—FEM, masonry, minor historical architecture, modal analysis.

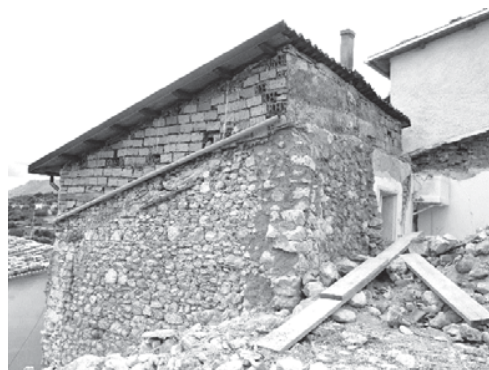
Fig. 3 Typical residential building

The external dimensions of the plan are nearly equal (6.43 m x 6.42 m), whereas floors have an average height of 2.8 m each. Following traditional use, the external walls are made of rubble masonry (average thickness 0.65 m), constituted by local sandstone and lime mortar. As a characteristic of long term building processes, many buildings present the attic level that has been added successively, using industry produced clay blocks and air lime mortar (Fig. 3).
