Damage Assessment and Dynamic Characteristics of Temples in Nepal Post Gorkha 2015 Earthquake

Eleonora Spoldi & Salvatore Russo

DCP, Dorsoduro 2206, 30123, IUAV University of Venice, Venice, Italy

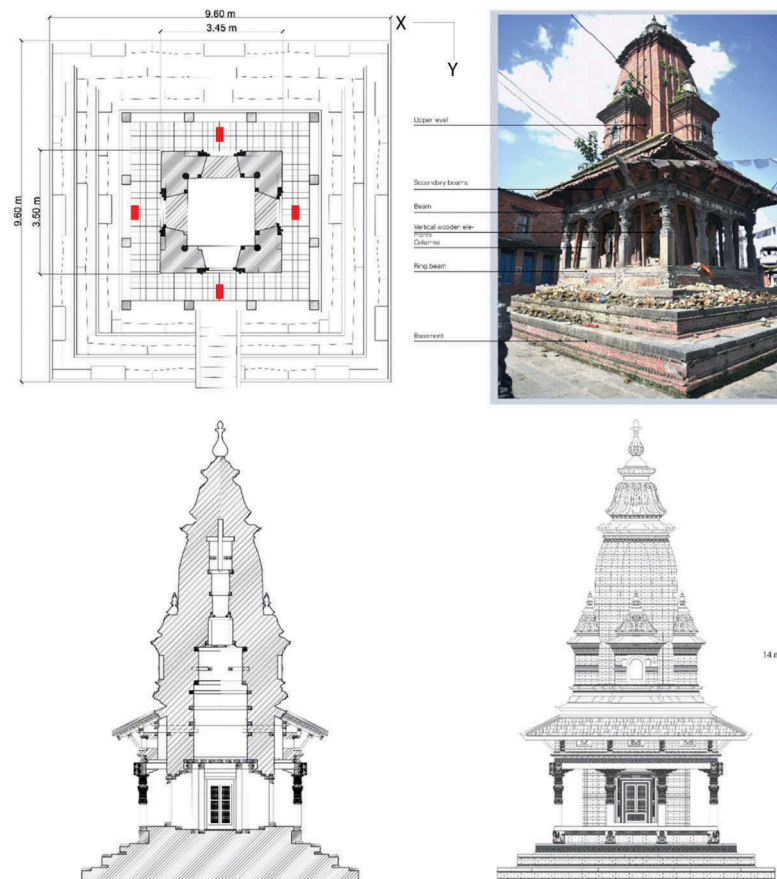
Figure 1. Radha Krishna temple, ground floor plan, section and South West front. The red squares indicate the tromograph position.

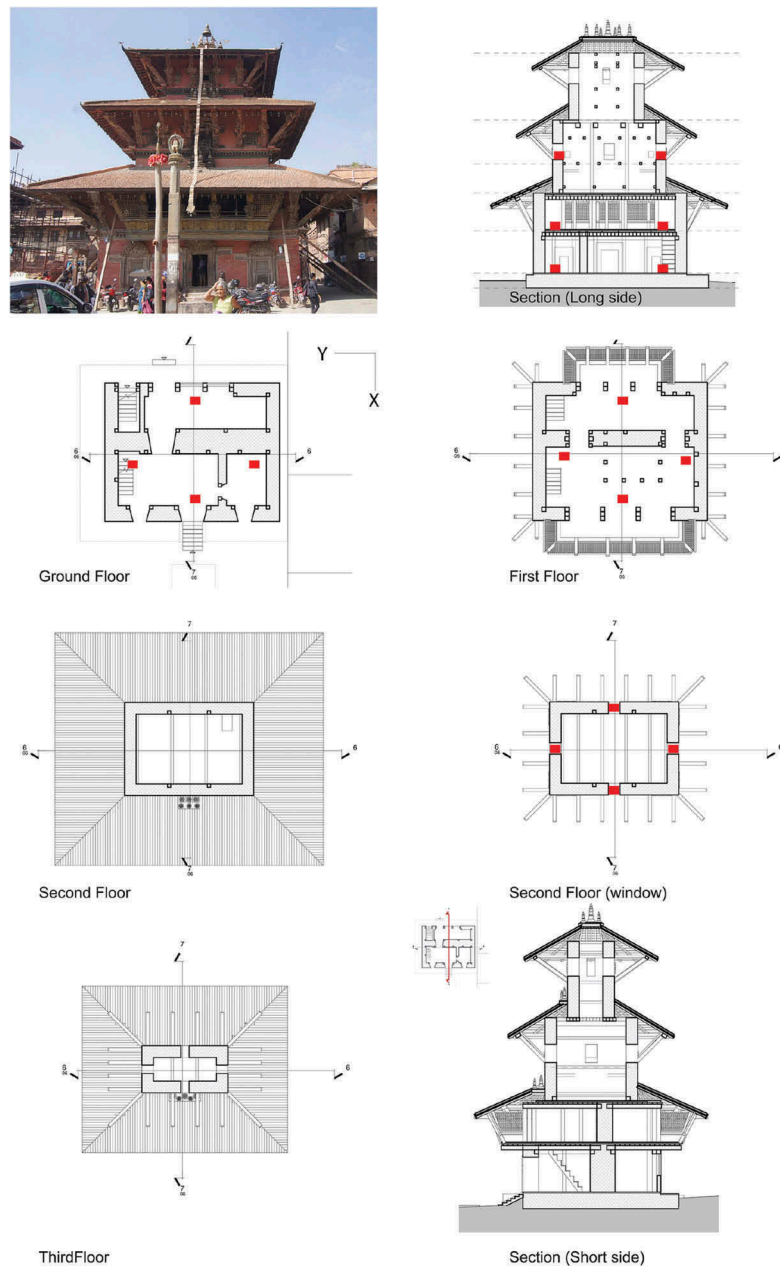
Figure 2. Bhimsen Temple, Patan. Sections and Plants. The red squares indicate the tromograph position.

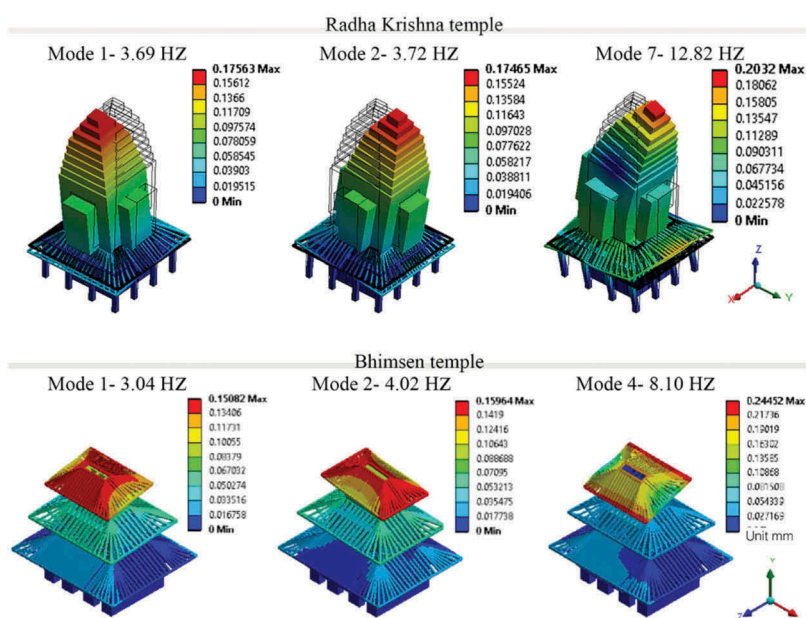
Figure 7. Result of modal analysis before calibration, Radha Krishna temple and Bhimsen temple.

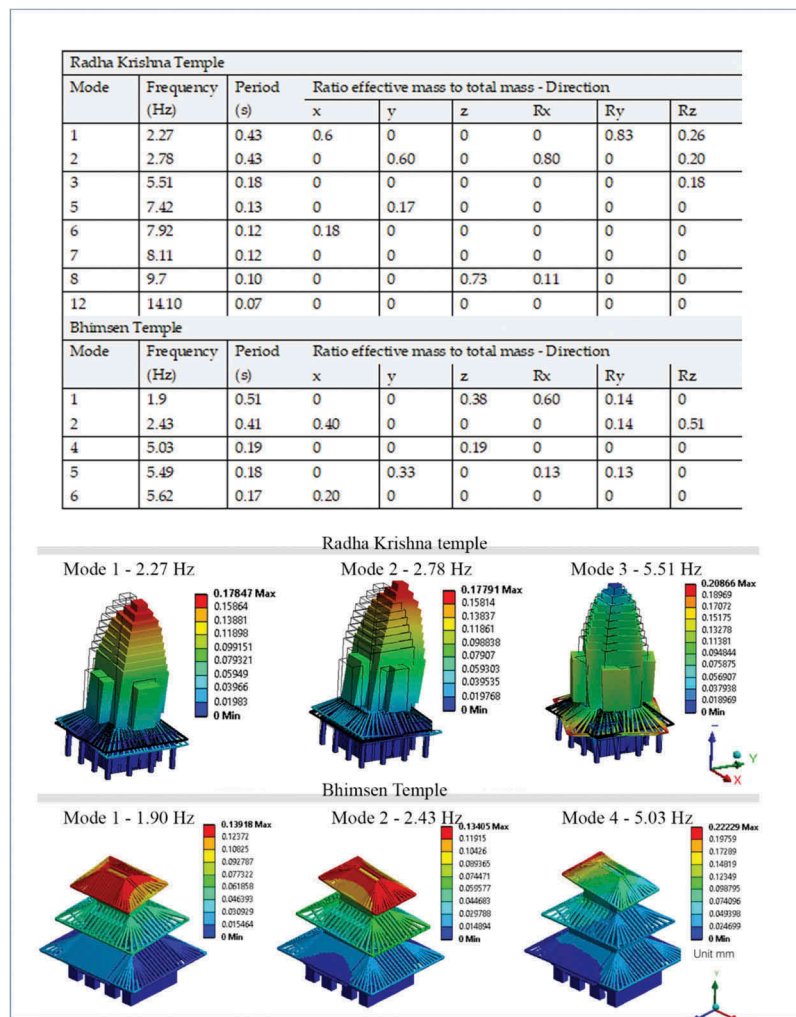
The model does not include the fair damage described in the “damage survey”. The Figure 8 shows the results obtained after the model calibration.

Figure 8. Result of modal analysis after calibration, Radha Krishna temple and Bhimsen temple.
