## Journal of Cultural Heritage

## Case study

## Church of San Pietro Martire in Verona: A conservation-oriented approach between historical and structural interpretation

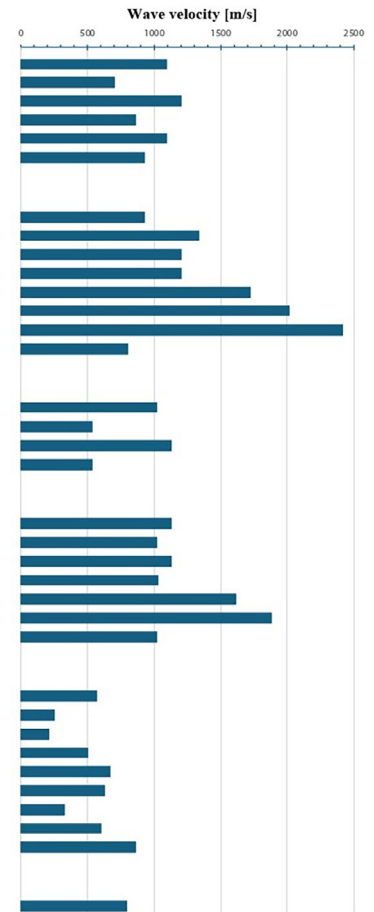
Test Code	Examined Section	Hammer Impact Point	Accelerometer Time [s]	Hammer Time [s]	$\Delta$	Wall Thickness [cm]	Wave Velocity [m/s]
M.01	Est wall	M.01a	10,84427	10,843854	0,000573	0,63	1099,48
		M.01b	5,197917	5,197031	0,000886		711,06
		M.01c	5,602239	5,601719	0,00052		1211,54
		M.01d	4,977344	4,976614	0,00073		863,01
		M.01e	7,016614	7,016041	0,000573		1099,48
		M.01f	5,960937	5,96026	0,000677		930,58
M.02	North wall	M.02a	5,794375	5,793698	0,000677	0,63	930,58
		M.02b	3,721927	3,721458	0,000469		1343,28
		M.02c	3,380469	3,379948	0,000521		1209,21
		M.02d	5,758489	5,757969	0,00052		1211,54
		M.02e	5,512812	5,512448	0,000364		1730,77
		M.02f	6,395312	6,395	0,000312		2019,23
		M.02g	3,1875	3,18724	0,00026		2423,08
		M.02h	3,926979	3,926198	0,000781		806,66
		M.03	West wall	M.03a	4,726302		4,725729
M.03b	2,177344			2,17625	0,001094	539,55	
M.03c	1,569375			1,568854	0,000521	1132,44	
M.03d	2,675573			2,674479	0,001094	539,31

M.04	West wall, roof space	M.04a	10,345729	10,345208	0,000521	0,59	1135,55
		M.04b	11,888906	11,888333	0,000573		1029,67
		M.04c	25,863281	25,86276	0,000521		1132,44
		M.04d	5,754531	5,753958	0,000573		1031,69
		M.04e	4,191042	4,190677	0,000365		1616,45
		M.04f	4,950625	4,950312	0,000313		1884,98
		M.04g	2,157604	2,157031	0,000573		1025,71
M.05	North wall	M.05a	7,858177	7,857083	0,001094	0,63	575,87
		M.05b	4,463073	4,460625	0,002448		257,35
		M.05c	4,790677	4,787708	0,002969		212,19
		M.05d	4,104687	4,103437	0,00125		504,00
		M.05e	5,163281	5,162344	0,000937		672,36
		M.05f	3,268073	3,267083	0,00099		636,36
		M.05g	2,682292	2,680417	0,001875		336,00
		M.05h	6,954062	6,953021	0,001041		605,19
		M.05i	6,337448	6,336719	0,000729		864,20
		M.06	East wall pillar	M.06a	4,4425		4,441562

Test Code	Examined Section	Average Shear Wave Velocity [m/s]	X	Average Longitudinal Wave Velocity [m/s]	Density [kg/m <sup>3</sup> ]	Young's Modulus	
						[N/m <sup>2</sup> ]	[Mpa]
M.01	Est wall	985,86	0,58	571,80	2000	1630231012	163,02
M.02	North wall	1459,29	0,58	846,39	2000	3571951651	357,20
M.03	West wall	810,24	0,58	469,94	2000	1101159338	110,12
M.04	West wall, roof space	1265,21	0,58	733,82	2000	2685018733	268,50
M.05	North wall	518,17	0,58	300,54	2000	450363095	45,04
M.06	East wall pillar	799,57	0,58	300,54	1800	460995630	46,10
