6th International Building Physics Conference, IBPC 2015

"Retrofit of an historical building toward NZEB"

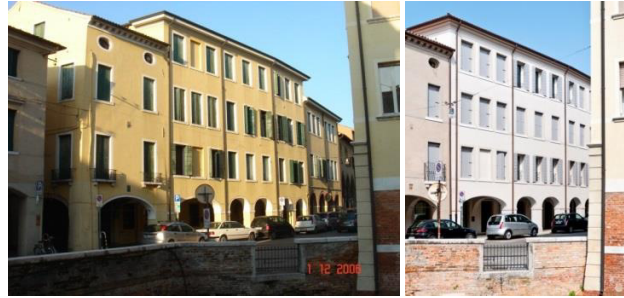
Fig. 1 General view of the building a) before and b) after the intervention.

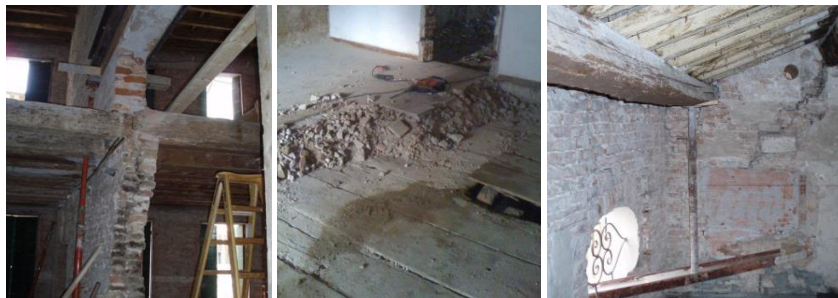
Building envelope before renovation presented a traditional construction system, based on bearing masonry with covered solid bricks. The floor had a wooden structure, while the ground floor leaned directly on soil. The roof is made of hollow tiles sheets with a wooden structure and a lightweight ceiling slab (Fig. 2).

Fig. 2 Building envelope before renovation: a) crooked walls; b) demolished partition walls left and used as a substrate; c) beam support in the perimeter wall.

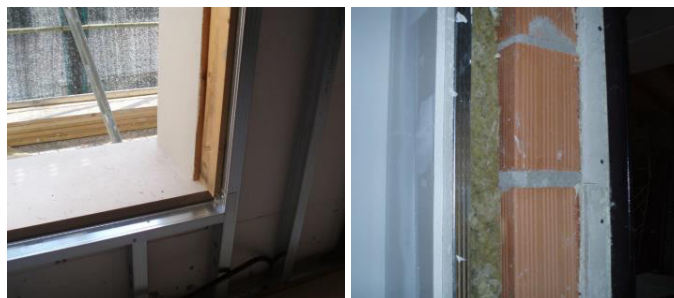
In the external walls the insulation is placed on the inner part (Fig. 3) and this solution meet the requirements of the Superintendence of Veneto Region, preserving the existing materials and the external architectural identity of the building. Specifically, two types of insulating are used: an expanded polystyrene (EPS) foam, placed directly on masonry, and a rigid mineral wool panel with a plasterboard cover. Roof was replaced with a new wooden structure and it was insulated with wood fiber and water tight covering. All existing windows are replaced with a low-energy double layer ones within wooden frames.

Fig. 3 Insulation on a) internal and b) external walls.

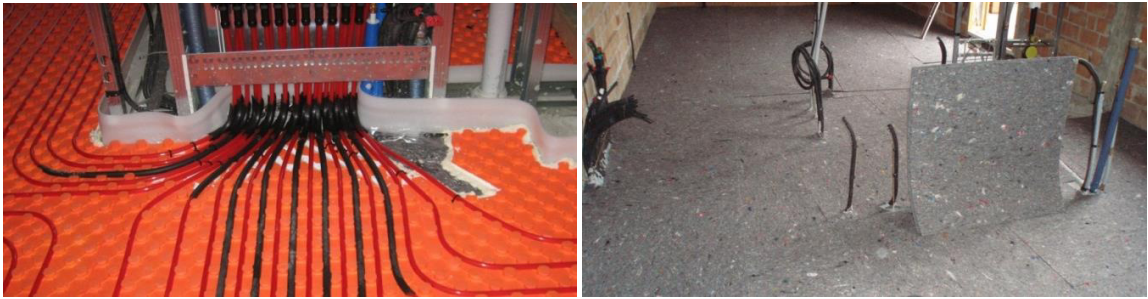
About technical systems, the HVAC generation system is a water to water centralized heat pump/chiller. The underlying well is the hot/cold water source and internal comfort is achieved exploiting a radiant system (Fig. 4) installed in the floor together with a dehumidification system for the summer period.

Fig. 4 Radiant system: a) collectors and b) TNT underflooring above system.

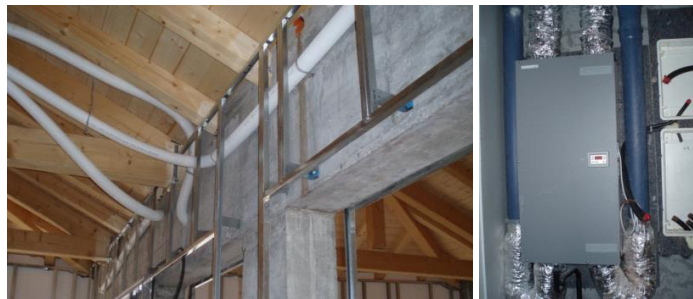
For heating and cooling the system adopted is a 32 kW heat pump with a distribution by radiant floor system; another heat pump (20 kW) is installed for domestic hot water requirement (DHW); mechanical ventilation (Fig. 5) is provided by a system with heat recovery box (95% efficiency).

Fig. 5 Mechanical ventilation system.
